Date Issued: April 1996

Revision Level: 0

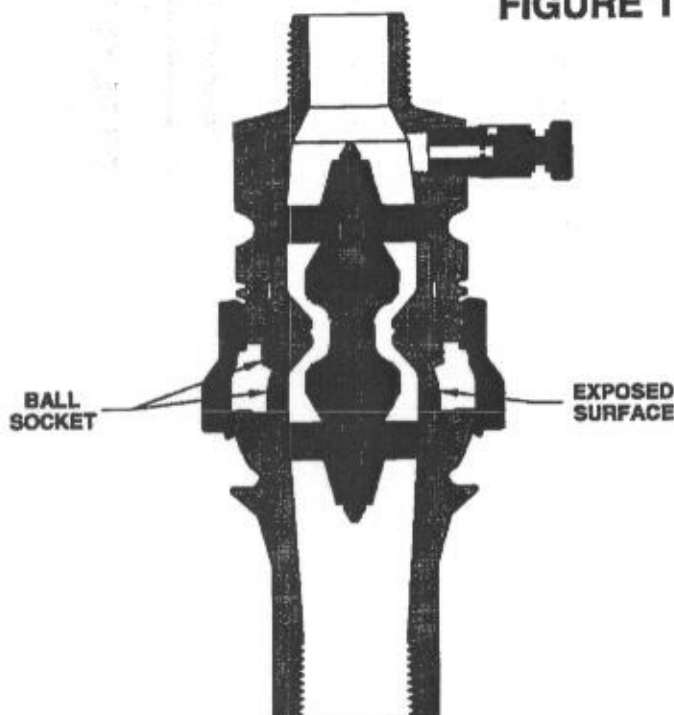
FIGURE 1

Field observations of Tripod Safety Couplers have revealed discoloration and surface imperfections on a few of the 316 stainless steel ball sockets, see Figure 1. These blemishes only affect the non-critical surfaces exposed to the atmosphere. **The surface imperfections will not affect the operation of the Tripod Safety Coupler.** The change to the surface finish is caused by atmospheric corrosion on the 0.001 thick surface layer. It will not effect the 316 stainless steel base material of the part.

To remove discoloration for aesthetics proposes, a fine emery should be used to clean the blemished area only on the ball socket. Do not attempt to remove the black surface on the ball sockets.
