SAFETY ALERT BULLETIN

for
AL424 MINIMUM BLEED VALVES

Form SB-AL424, Rev 01

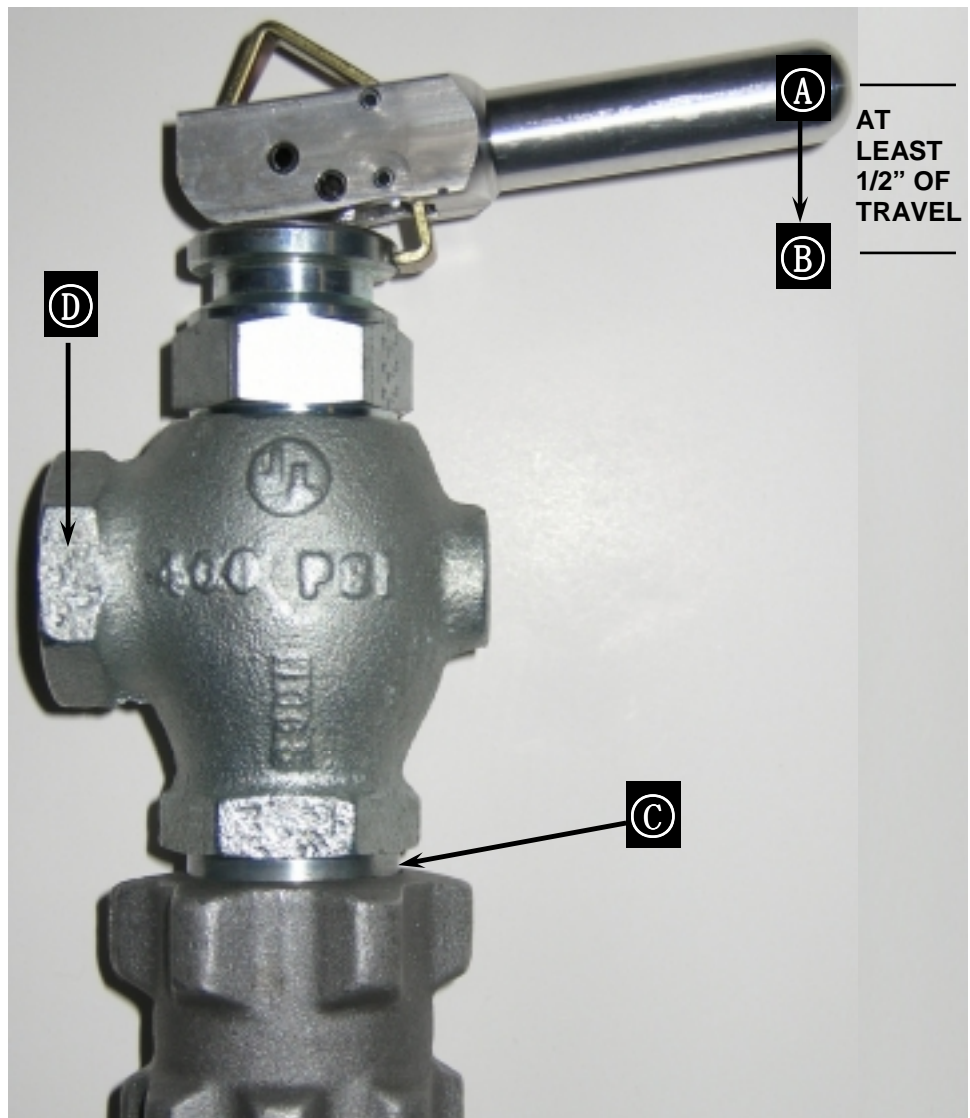
The AL-424 Minimum Bleed Hose End Valves with a build date of 09-2004 (on one flat at location ④) have experienced intermittent problems in the field. When the hose and valve body is improperly, but commonly, rotated counter-clockwise to break loose the Speed Nut after filling is complete, the Body-to-Nozzle joint at ③ is loosening on some valves. If the joint is loosened over one turn without being noticed, the snap-acting closure mechanism of the valve is unable to function properly and completely shut off the valve. As a result, the user is unable to remove the Hose End Valve from the vessel being filled.

When this condition occurs, the user can simply retighten the joint which allows the closure mechanism to operate properly, but nevertheless, the loosening of the joint is unacceptable.

Valves that loosen at the Body to Nozzle joint ③ should be returned to Squibb-Taylor for repair. To ensure that there is enough slack in the closure system to allow the valve to operate properly, please do the following:

- With the valve in the CLOSED position, place the handle in position ①. (It should NOT need to be held in this position.)
- Then press downward on the handle as far as it will go to position ②.
- The travel at the tip of the handle should be MORE THAN 1/2 INCH.
