Coro-Vane Maintenance and Disassembly

CoroVane Pumps

The following slides depict a 1021, but all standard pumps are repaired the same.

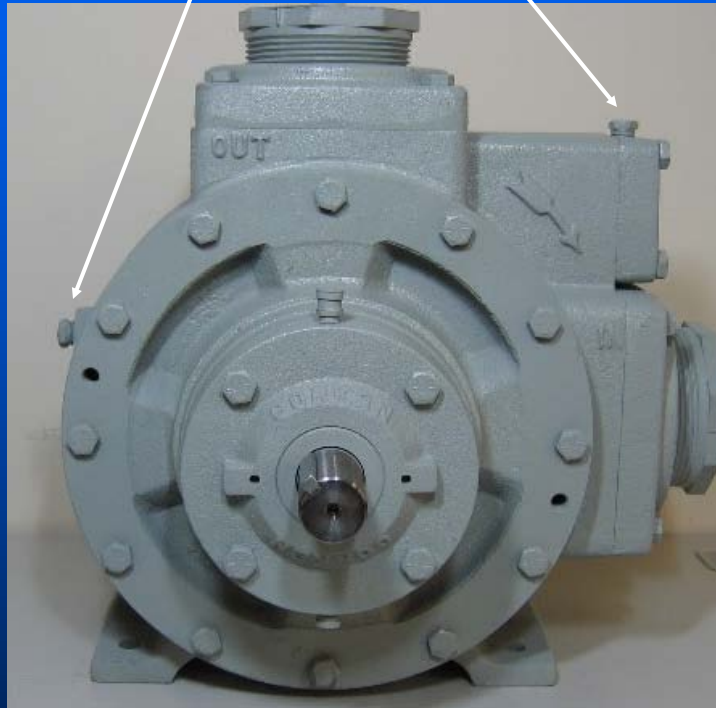
Pumps all have discharge and suction pressure openings.

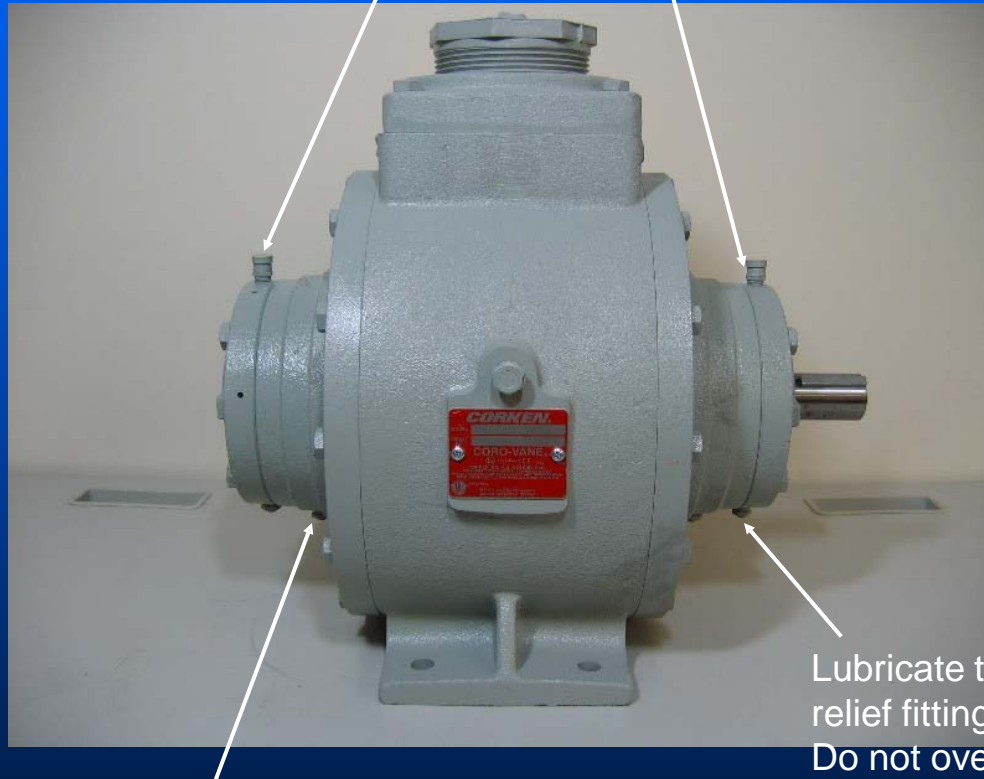
Grease fittings are on both sides of the pump. Typical pump should be lubricated every 1 – 3 months depending on service

Lubricate the bearings only until the relief fitting pin moves.
Do not over-grease!

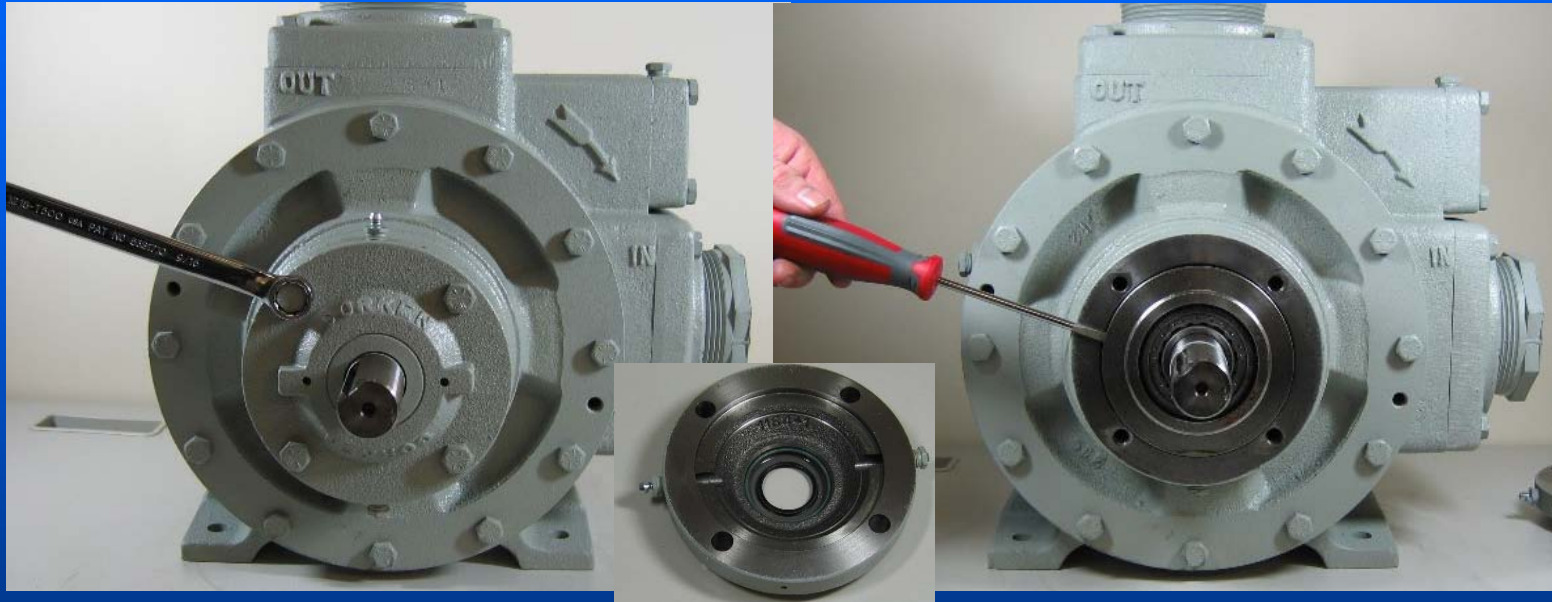
Bearing Cap Removal

Before any repairs, confirm all pressure has been relieved. Remove the bearing cap bolts and bearing cap. The grease should be cleaned from the bearing cap and the grease seal removed and replaced. The bearing housing may be removed with one or two screwdrivers using the groove on the diameter of the housing to pry out the housing. If the housing is difficult to remove the head may be removed and using a rubber hammer or piece of wood, drive the housing out from the back.

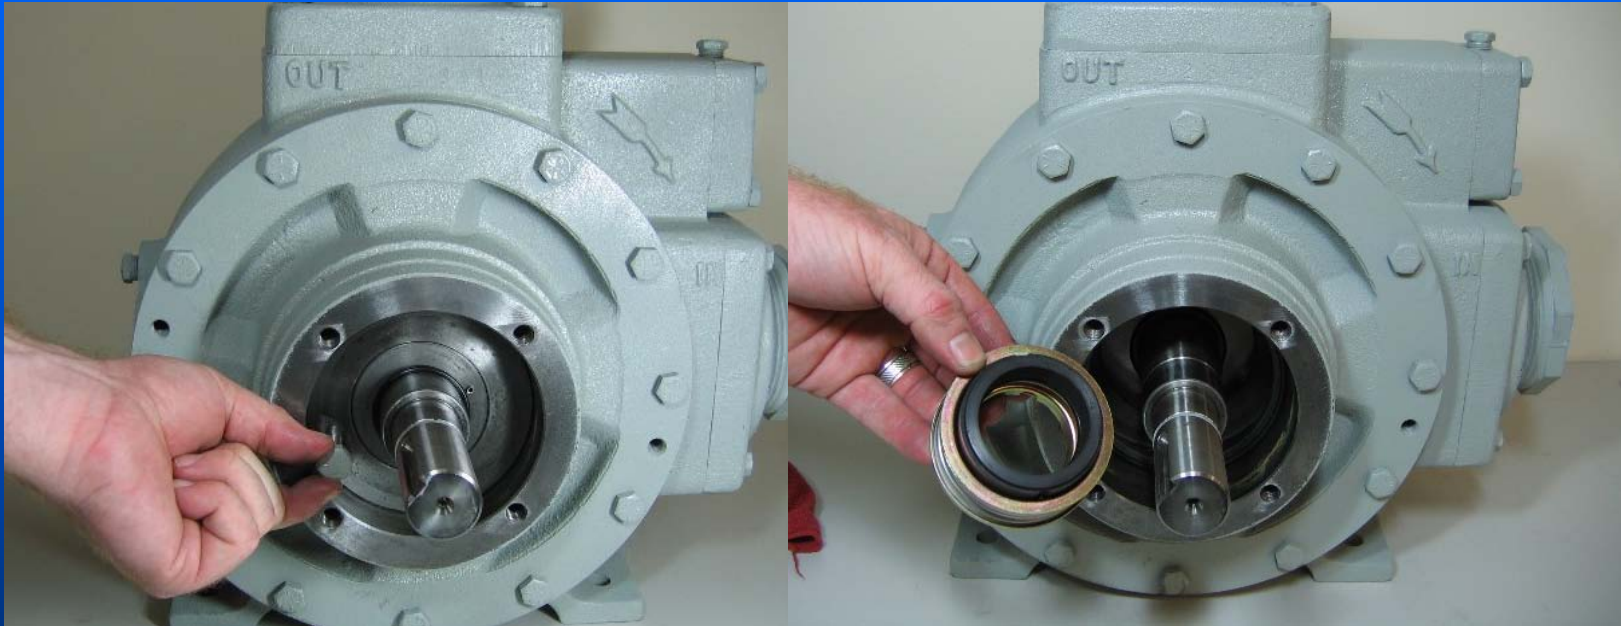
Seal Removal

The inside of the head and the shaft should be cleaned before installing a new seal. The seal may be lubricated with a light oil or spray lubricant during assembly. Seals are precision parts and care must be taken during handling. **KEEP HANDS CLEAN!**

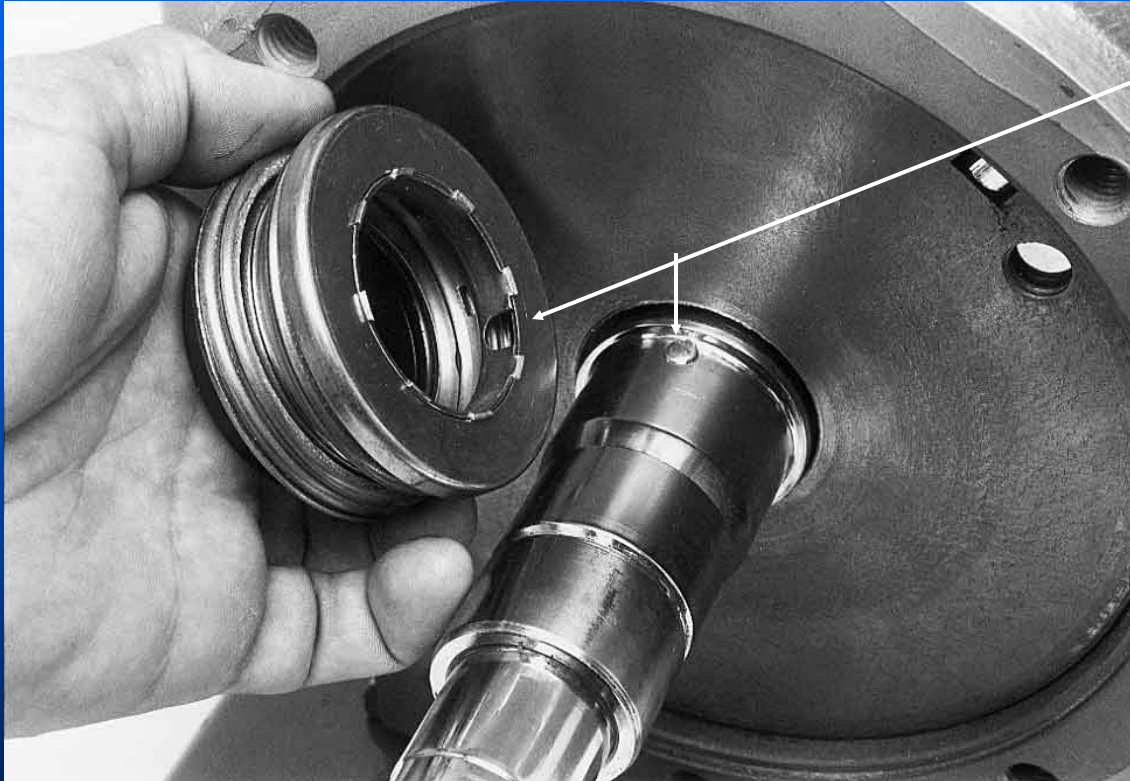
Seal Spring Alignment

The seal spring has a notch that must align with the pin on the shaft. It is best to install the spring first, then install the carbon and O-ring.

The seal may be lubricated with light oil or a spray lubricant. Seal are precision parts. Care should be taken handling the seal faces.

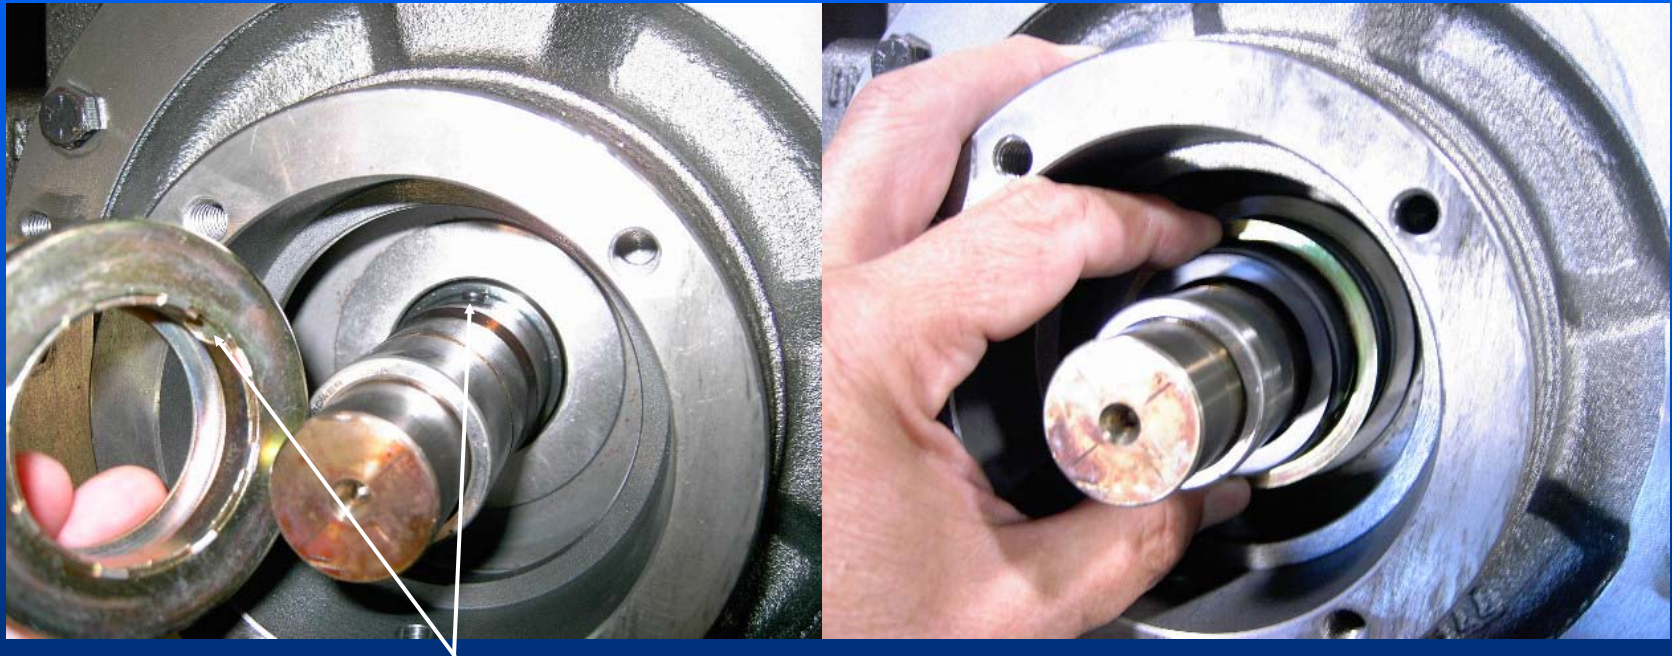
Seal Installation

Seals are a precision machined part and care should be taken to maintain the surfaces clean. Light oil or spray lubricant may be applied to the surfaces.

Clean the shaft surface where the O-ring seals prior to installing the spring. When installing the seal it is easier to install the spring retainer first, watching the seal pin alignment.

After the spring retainer is installed the carbon can be inserted into the spring, watching that the notches on the O.D. of the carbon align to the tabs on the retainer.

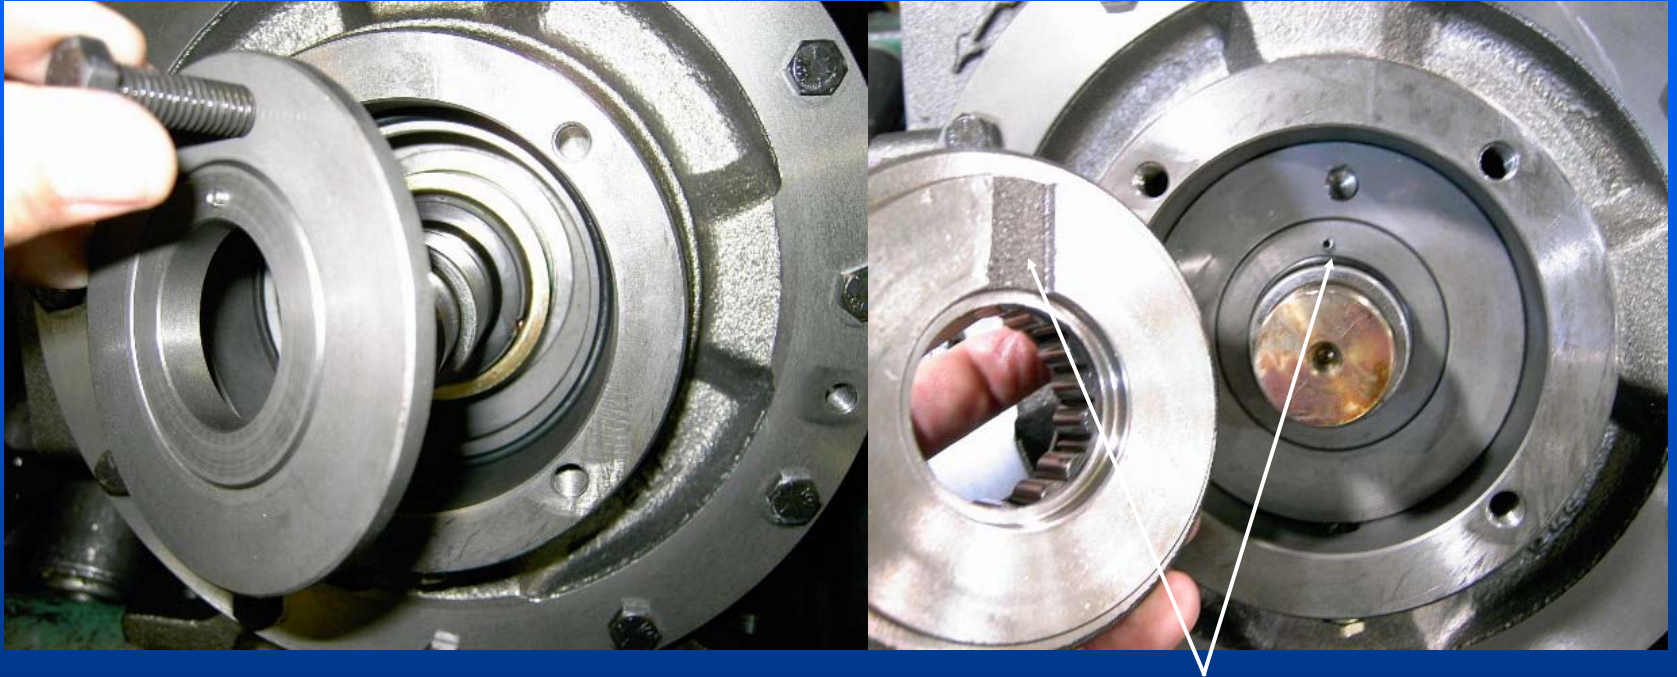
Installing Bearing Housing

Install the seat in the seat adapter and carefully install the assembly over the shaft. Take care not to hit the seat against the shaft. Using a spray lubricant to rinse the faces will assure the surfaces are clean.

When installing the bearing housing watch the pin to notch alignment. Install the grease O-ring prior to installing the housing.

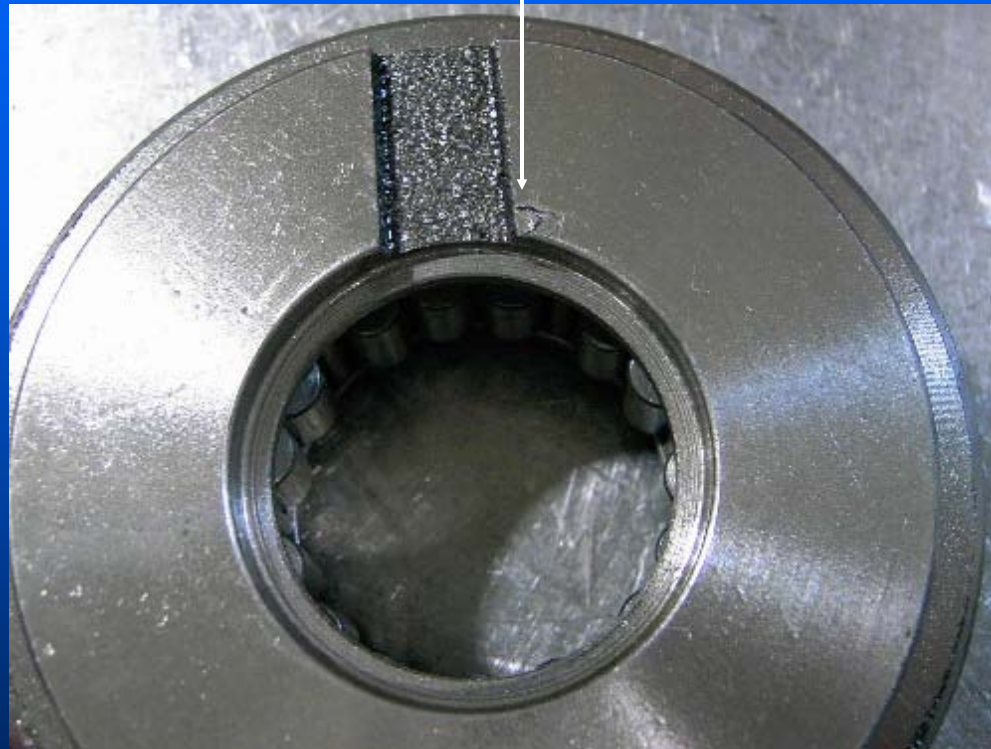
If the seal pin is missed it may leave a mark on the back of the housing. This mark should be filed flat to assure proper surface contact and seat alignment

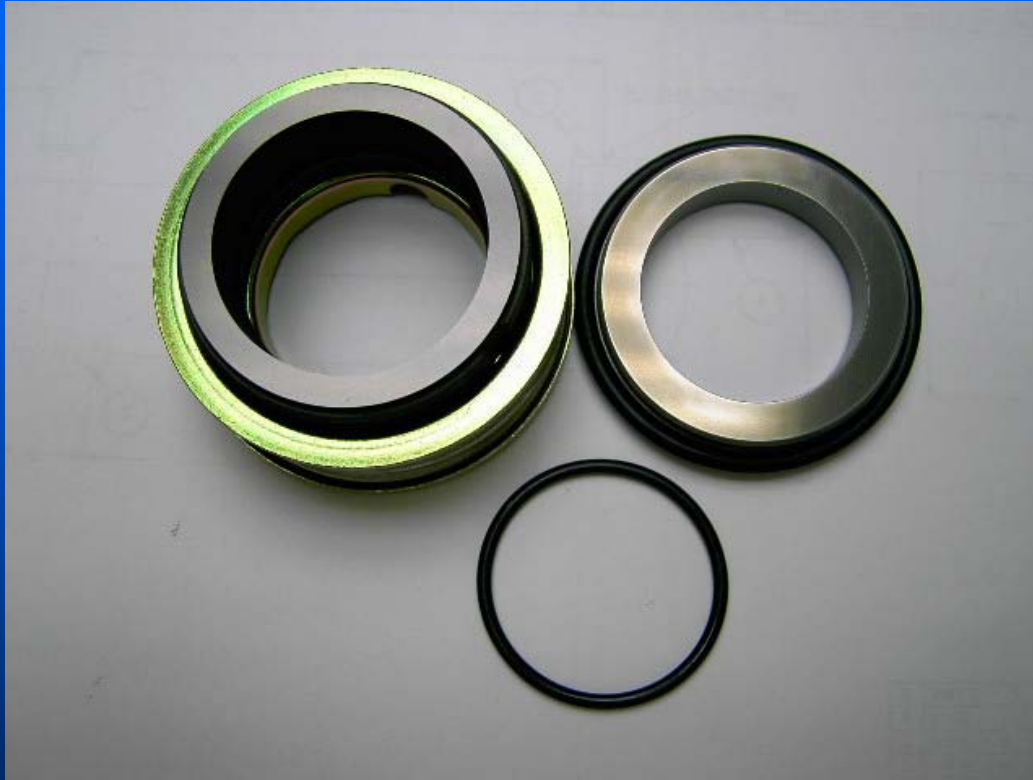
Seal Assembly

The seal assembly includes the seal parts along with the small grease seal O-ring.

<<<< This is as far as one needs to go if only changing the seal assembly! >>>>

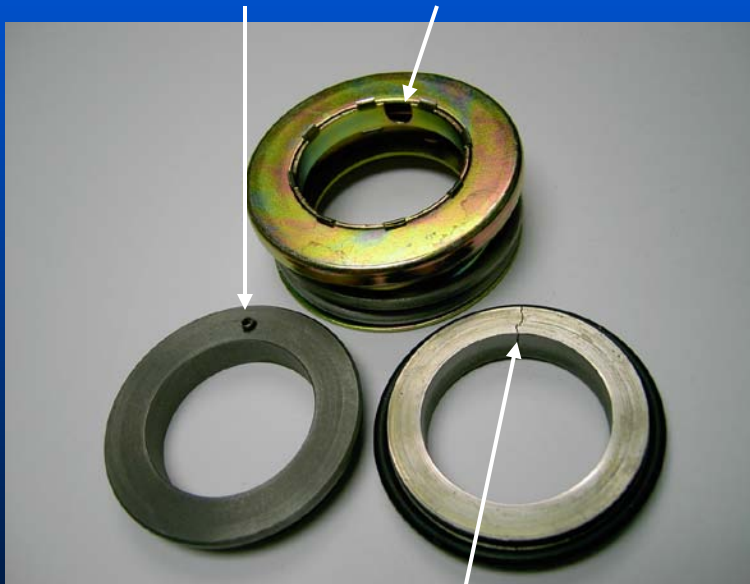
Alignment is critical. Watch both alignment pins.

Cracked seal from misalignment

All mechanical seals have a small amount of leaking “vapor”. The seal utilizes the liquid to lubricate the seal faces, which causes a small amount of vapor leakage. This should not be “dripping liquid” or “blowing vapor”. One may note a bubble slowly growing if tested with soap. There are many possible causes of seal leaks. Typically operating “dry” or without liquid in the pump or foreign material such as rust, cause the majority of the seal leaks.

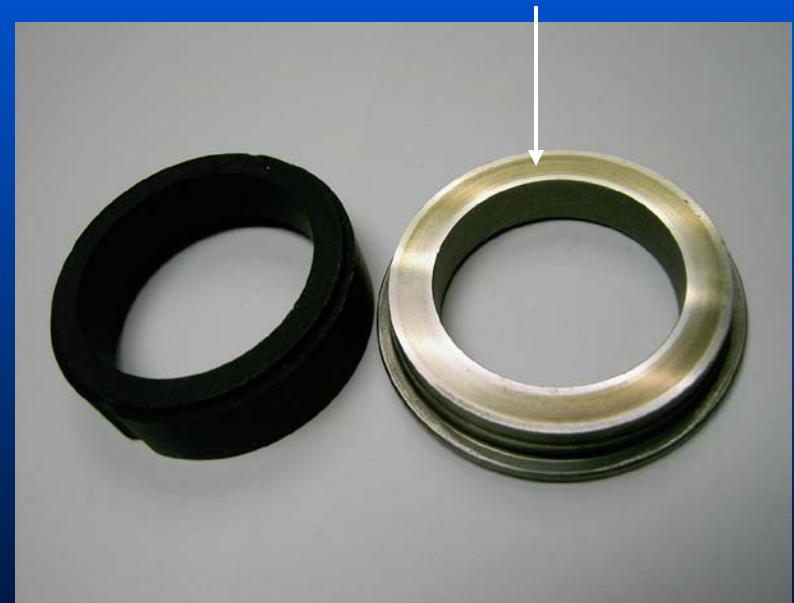
This is an example of a “dry” or hot seal.

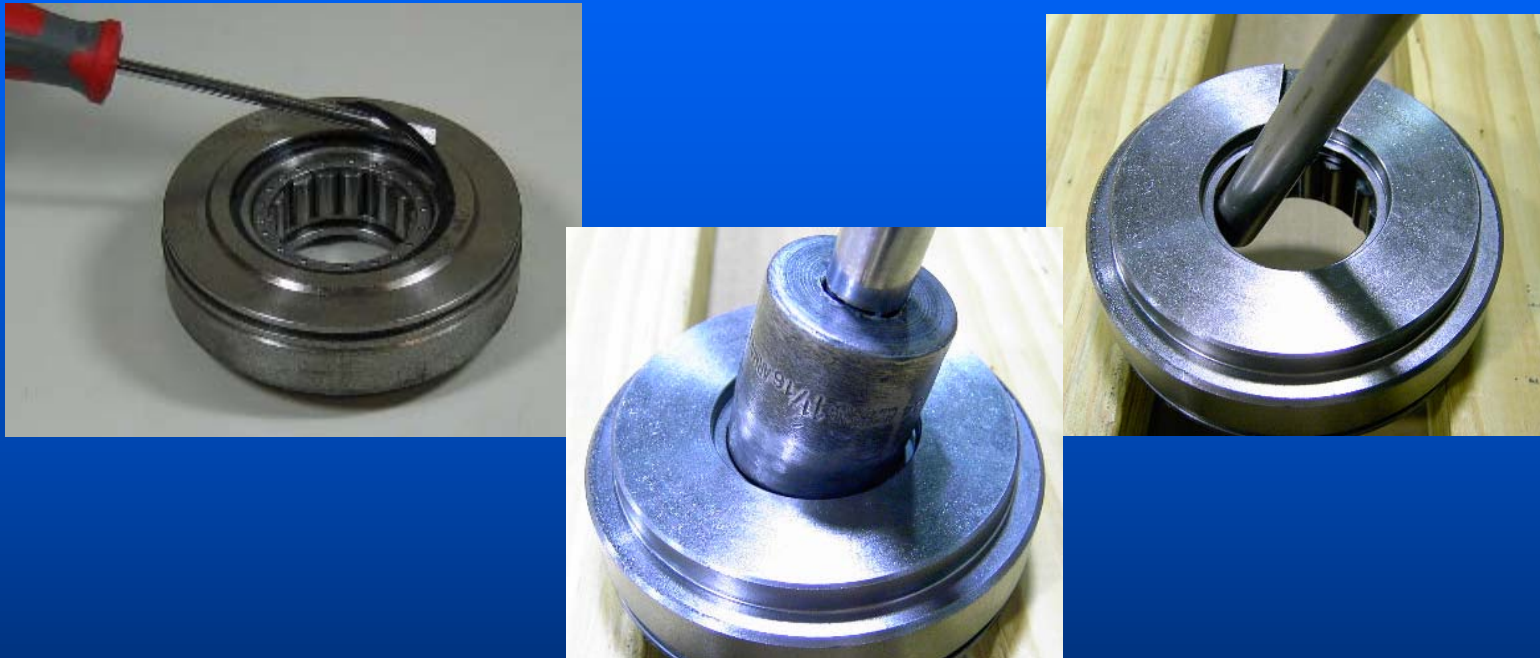
Bearing Removal

The main bearing can be removed by removing the spiral retainer ring and pressing the bearing out. A tool such as a socket or punch may be used to drive out the bearing. Both the inner and outer bearing should be changed together. The bearings may be “pre-packed” with grease during assembly, but it is not required.

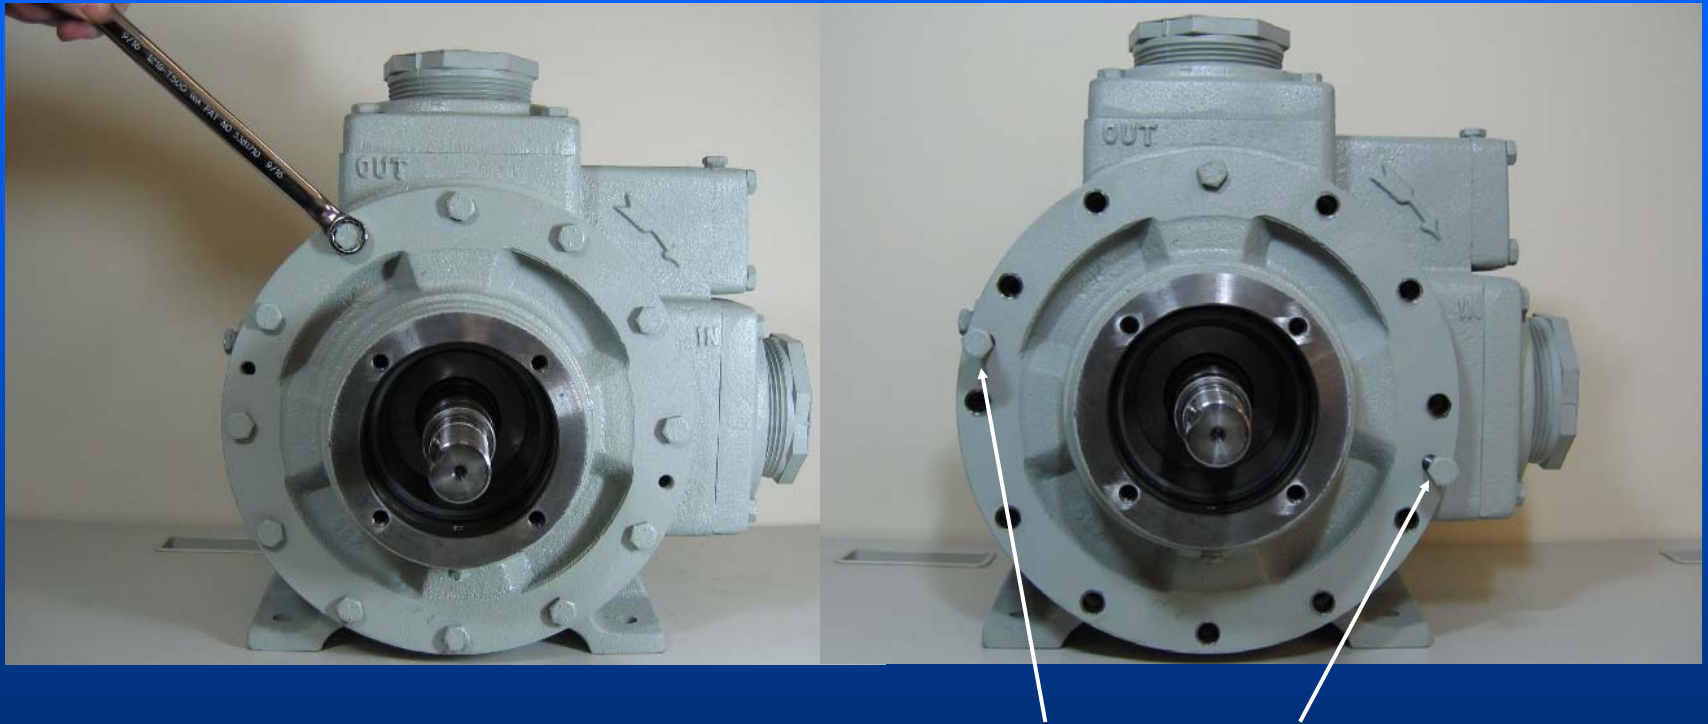
Head Removal

Remove the head bolts. There are threaded holes that may be used if needed to “push” the head off of the casing. If just changing a seal the head does not have to be removed.

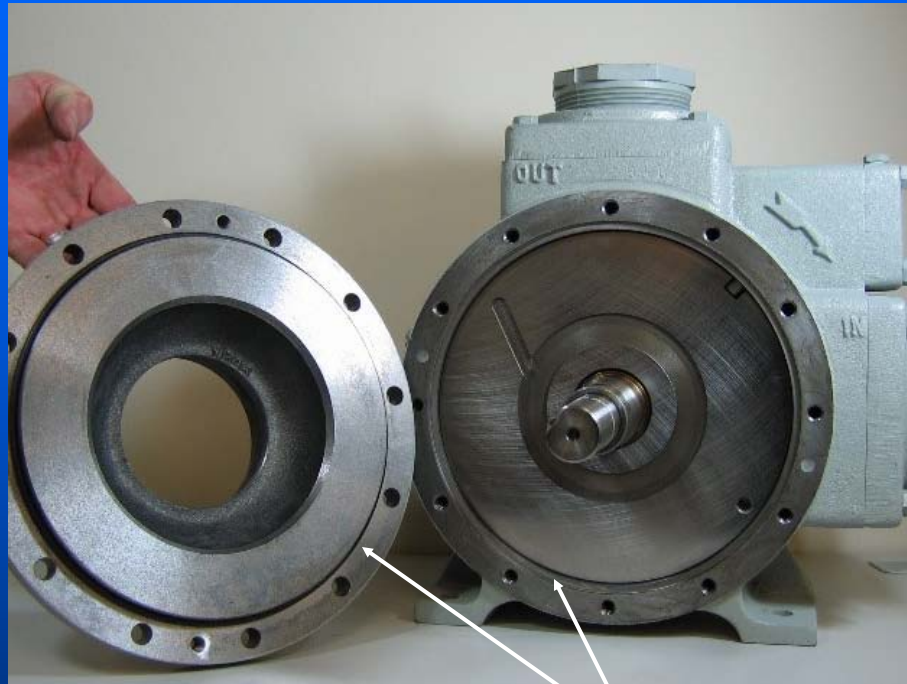
The head may be removed and the O-ring area of the case and head should be cleaned before assembly.

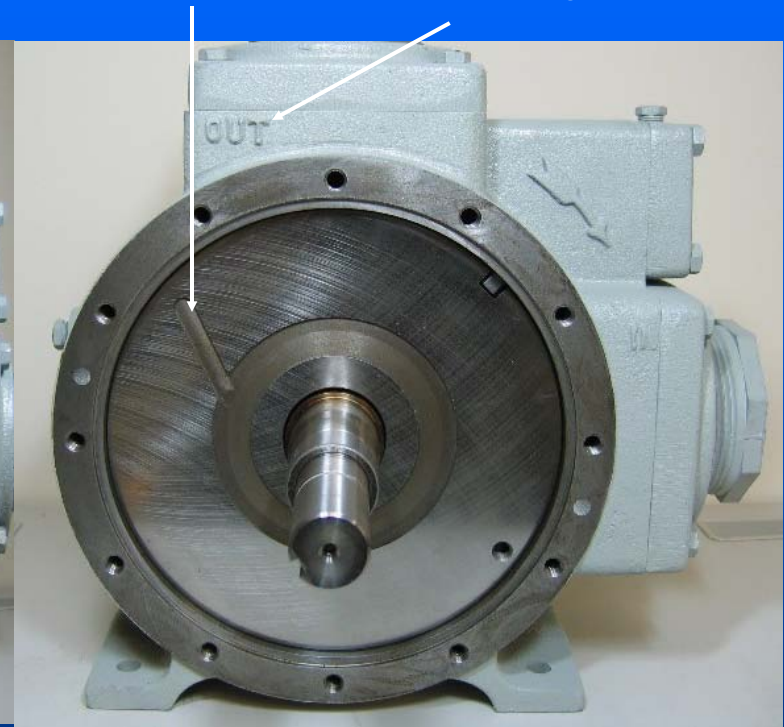
Feeder channel toward the discharge..

On the 1021 and 1521 the sideplate has a groove that must be directed toward the discharge side of the pump. If the plate is reversed it must move to the opposite side.

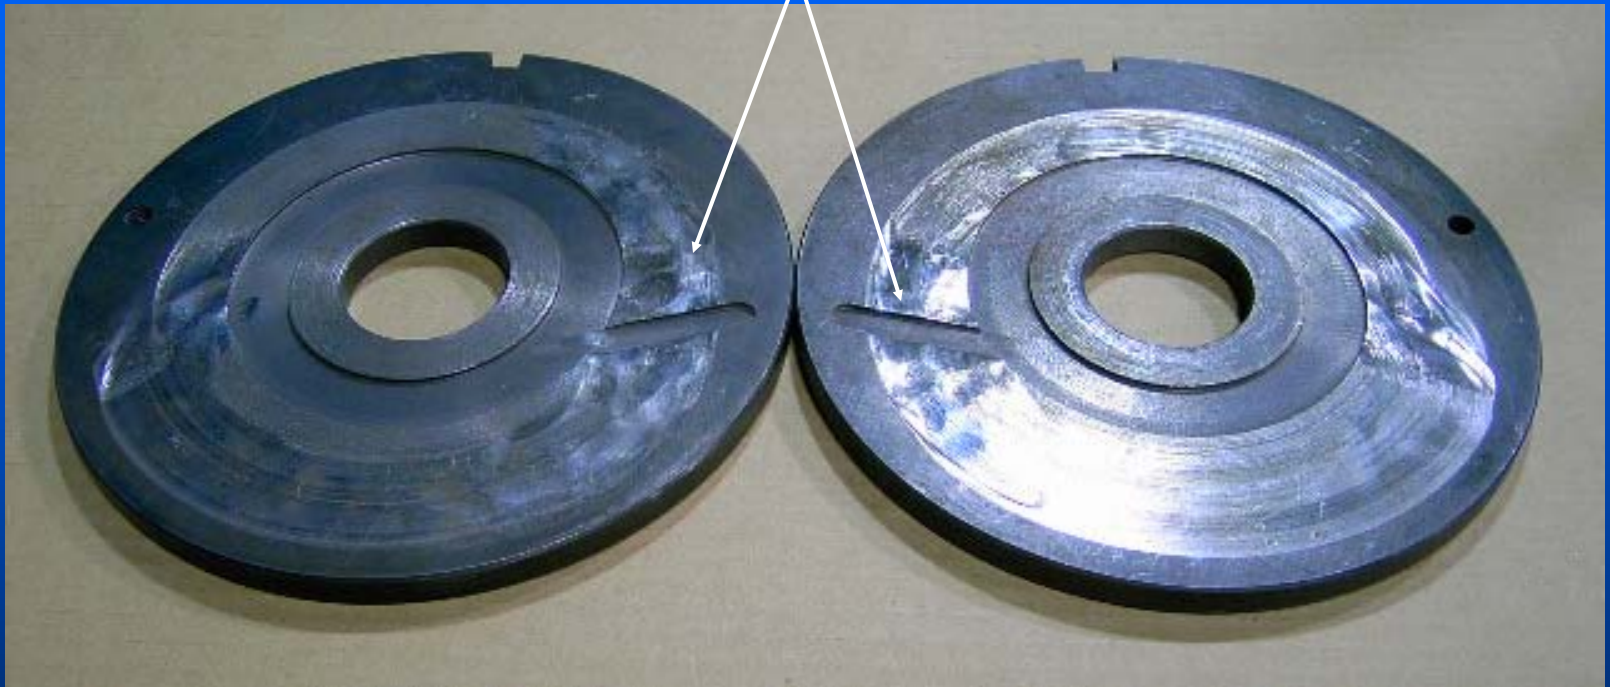
Excessive wear due to improper feeder channel position.

Scoring on sideplates may be caused by foreign materials such as rust, welding slag and other materials being pumped. Light scoring will not typically reduce pumping performance. Sideplates may be reversed or “flipped over” on all models except the F/T1521. Care should be taken to maintain the feeder channel toward the discharge side of the pump. The 1021 plates must change pump sides to be reversed.

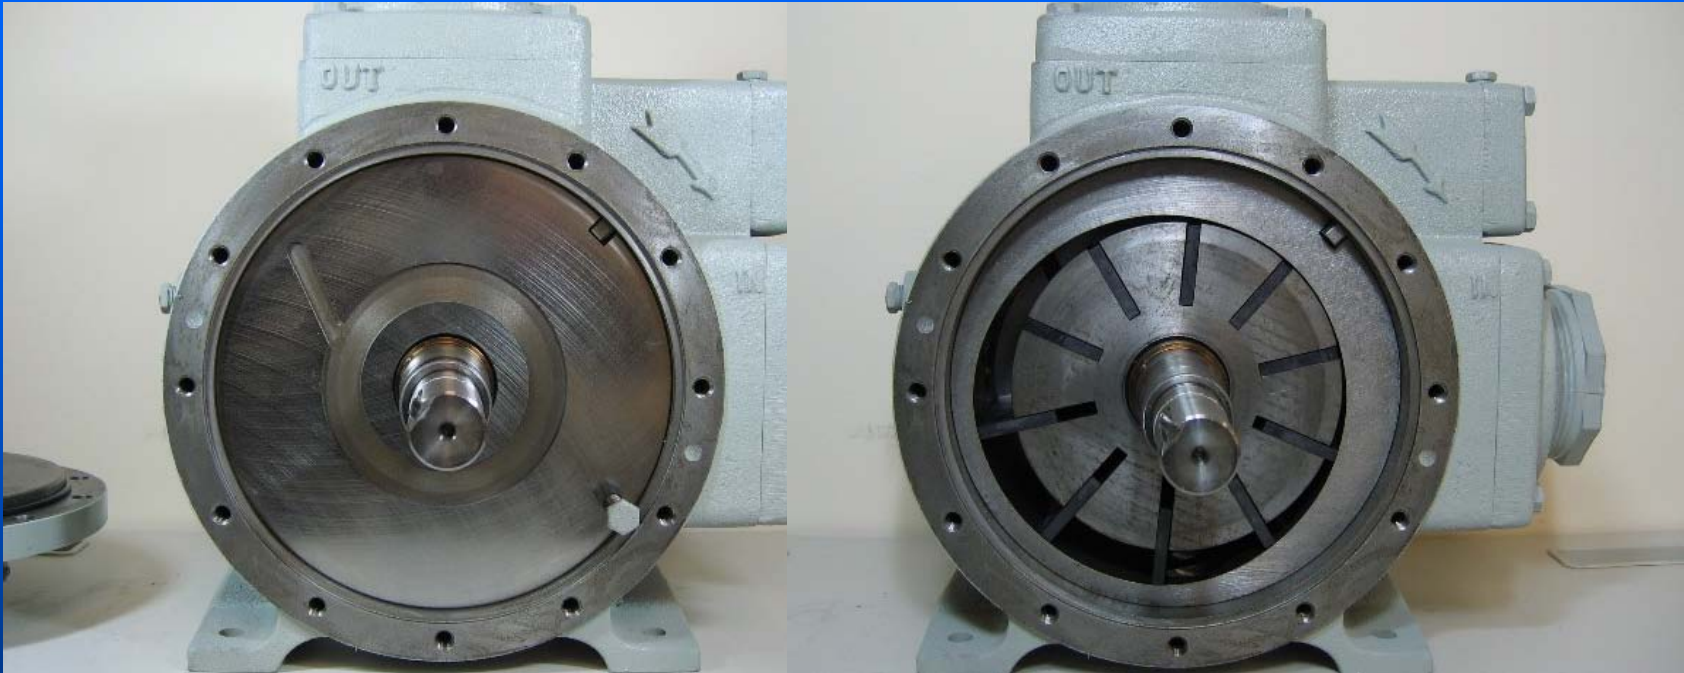
The sideplate can now be removed using a head bolt to assist. This allows access to the inside of the pump for inspection of the blades and cam.

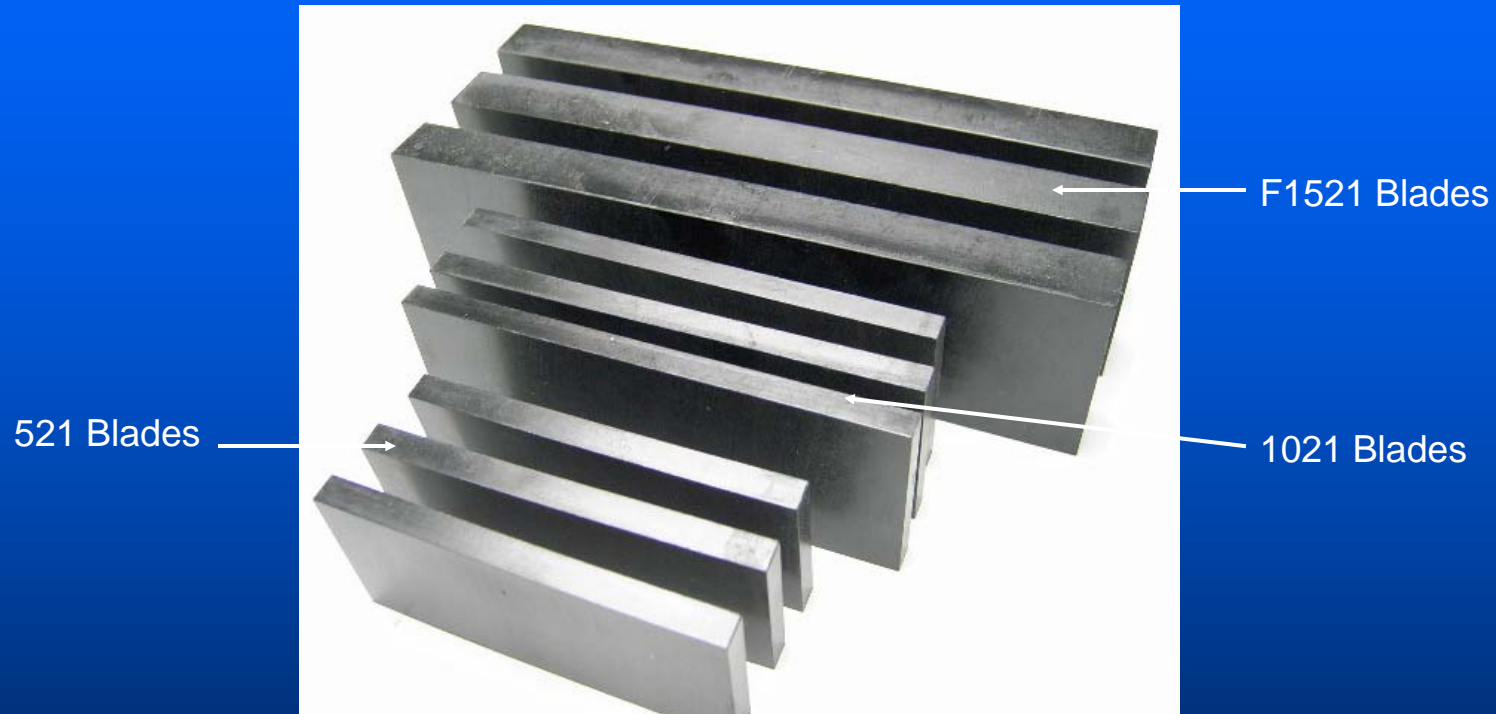
Standard Blades / Vanes

Standard 521/1021/F1521 pump blades are of solid design and may be reversed or flipped if any chipping or damage is noted. The blade should be changed when more of the blade is extended out of the rotor slot than is remaining in the slot. See the IOM manual for more dimensions.

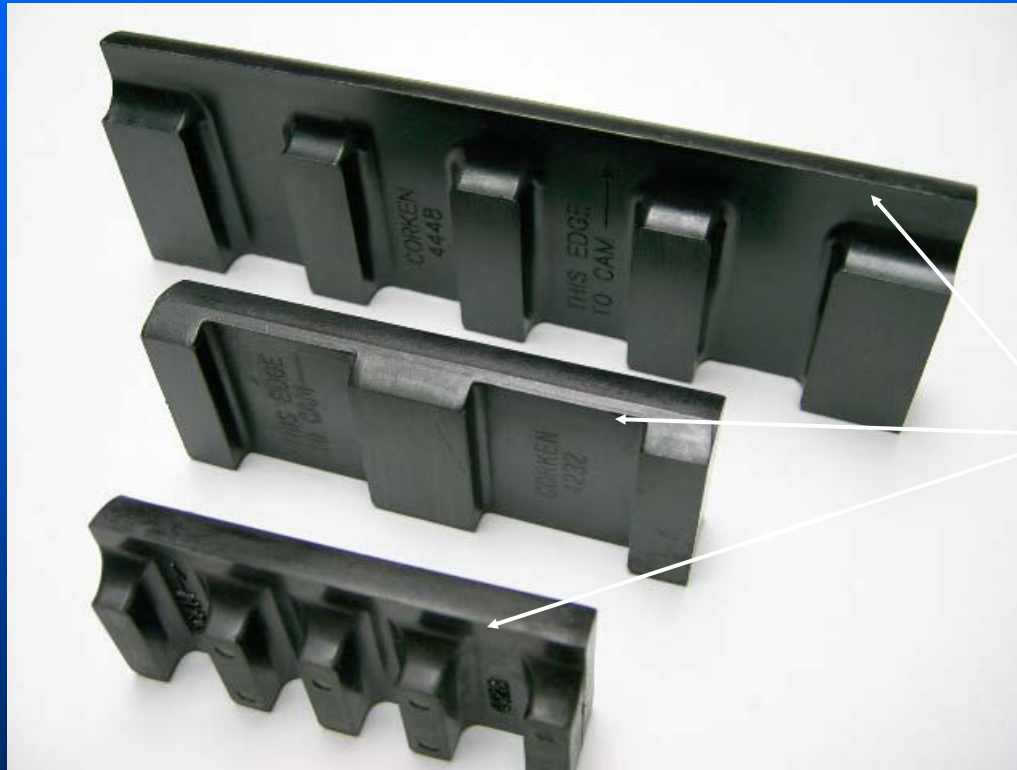
CD / CP / Z / PZ Blades

The leading edge of the blades must be toward the direction of rotation.

CD/CP/Z/PZ Blades vary in design of the leading edges and notches.

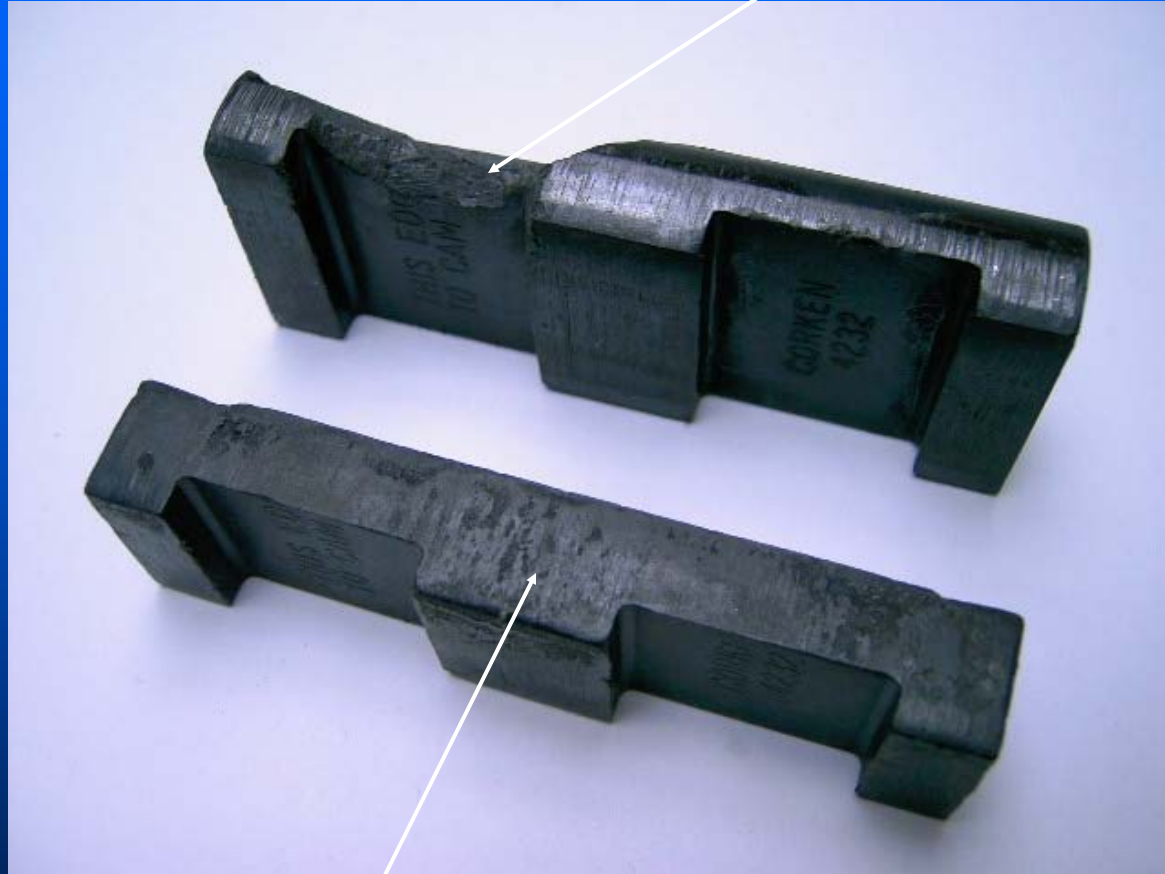
Blade damaged from foreign material

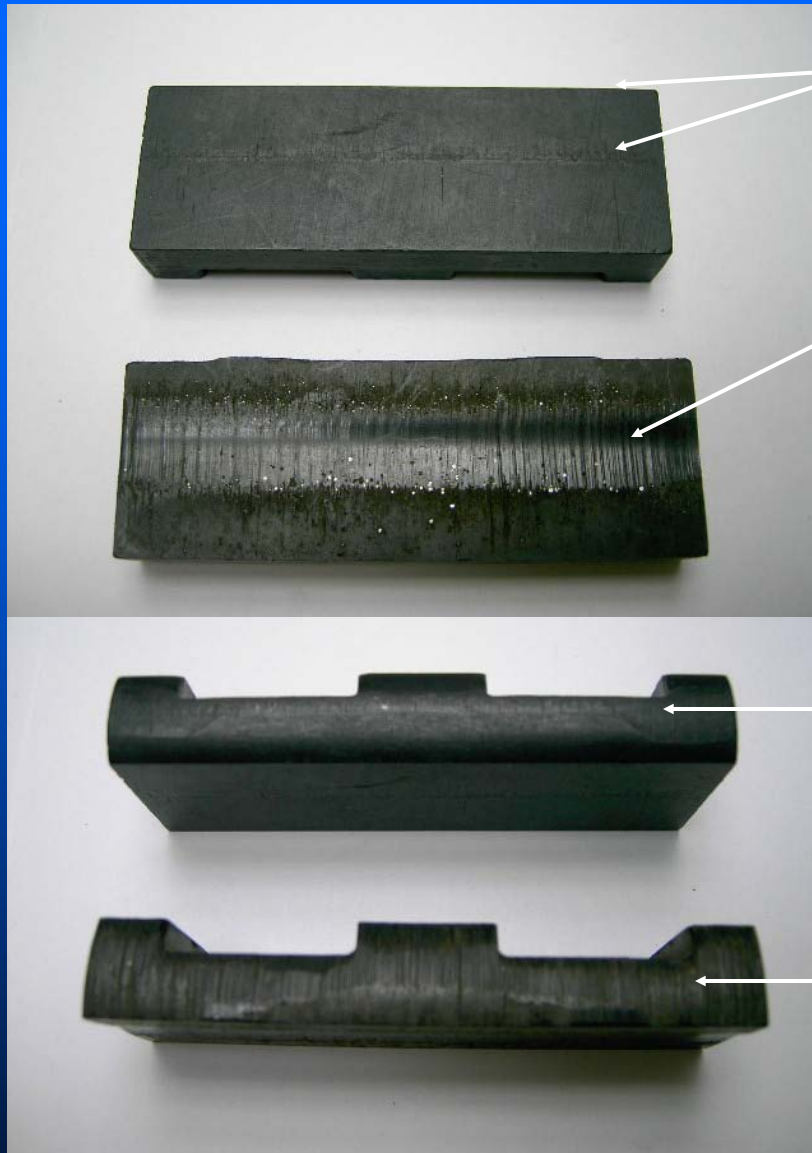
Blade damaged from "dry" running, and melted.

Blades should be inspected on both the back and the top that wears on the cam.

The higher the differential the more the "back" wear on the blade. Note the foreign material embedded in the blade. It appears to have had welding slag or other material go through the pump

Normal wear, operating with clean liquid.

Excessive wear from dry running and foreign material.

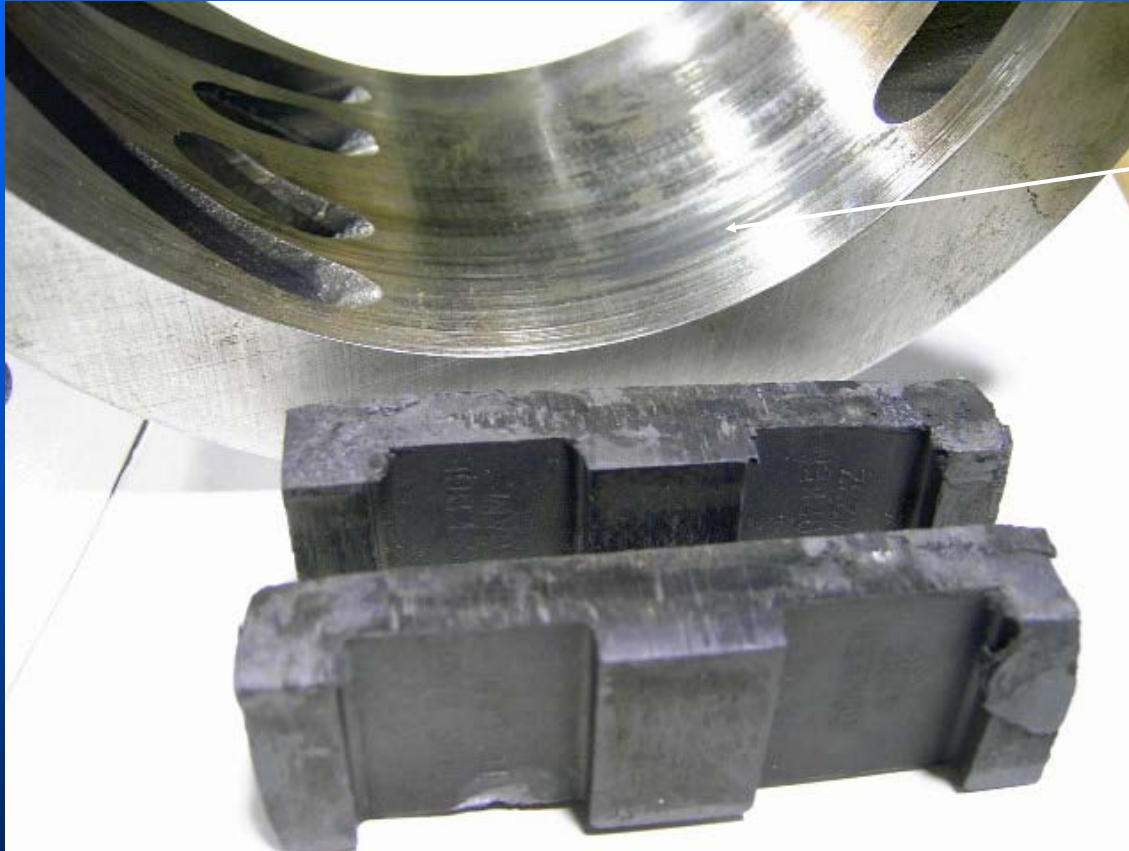
Melted blades – Dry Running

Melted blade material in cam
Inside diameter.

If a pump operates “dry” for very long it is possible to melt the blades.

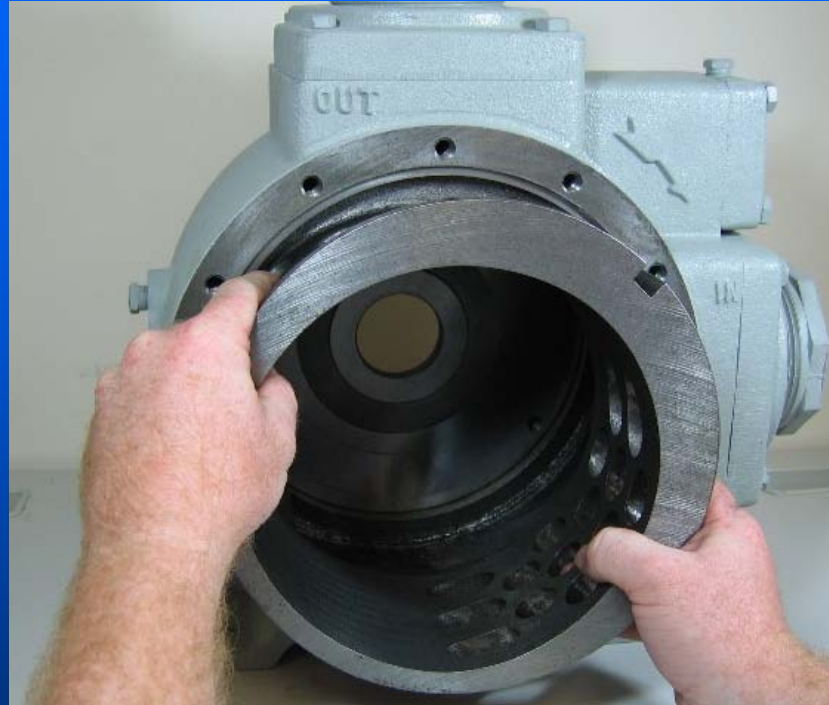
Cam Removal / Installation

The cam may be removed by using a piece of hardwood and tapping around the outer edge of the casting. The cam should be inspected for wear and scoring on the inside diameter. Small scratches seldom reduce pump efficiency, but if deep grooves are present the cam should be changed. "Washboard" type wear is usually caused by cavitation and the cam should be replaced.

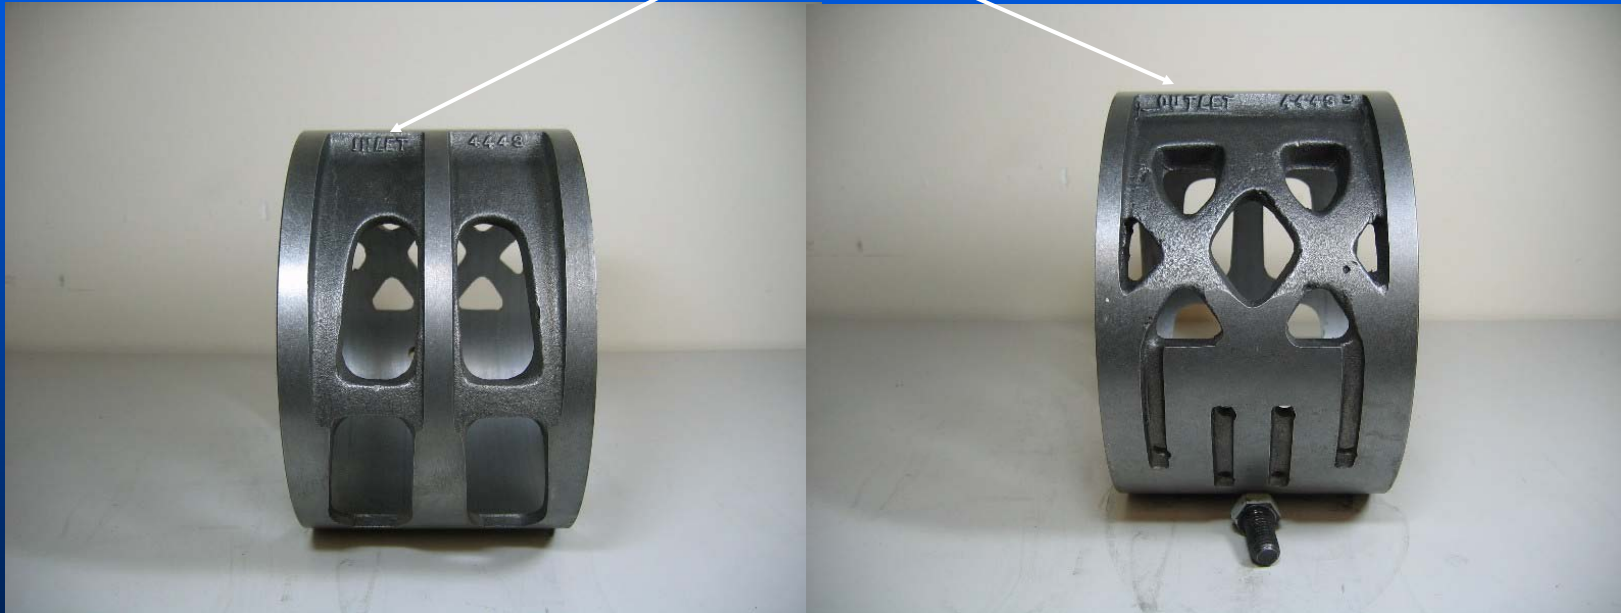
Cam/Liner

Cams or liners are marked for inlet and outlet or suction and discharge. They must be installed correctly or there will be a decrease in capacity and an increase in noise and wear. Typically the inlet will have more or larger openings.

Note feeder channel marks are towards the suction side of the cam.
