Coro-Vane Maintenance and Disassembly

CoroVane Pumps

The following slides depict a 1021, but all standard pumps are repaired the same.

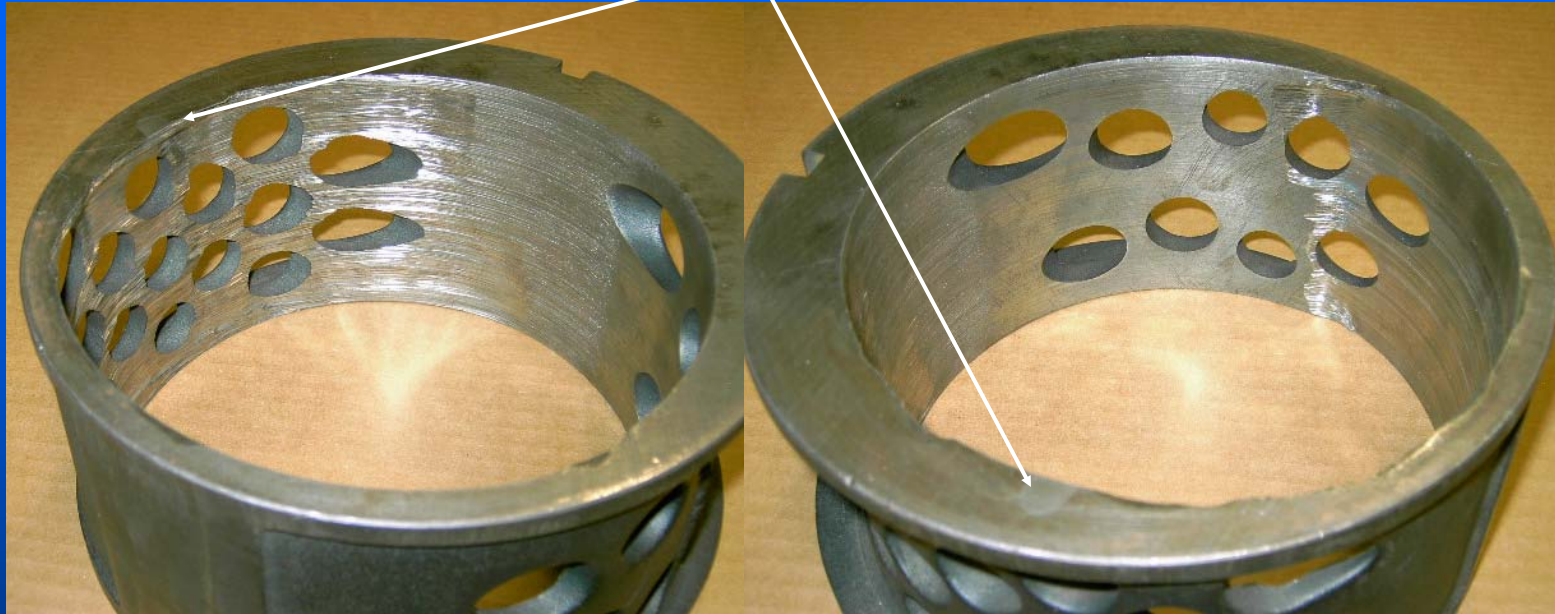
The above cam is severely worn due to the improper installation of the sideplates. The sideplates had been reversed, but had not changed sides placing the feeder channel towards the suction. This position maintains a low pressure behind the blades causing the blades to move back into the rotor slots instead of holding against the cam inside diameter.

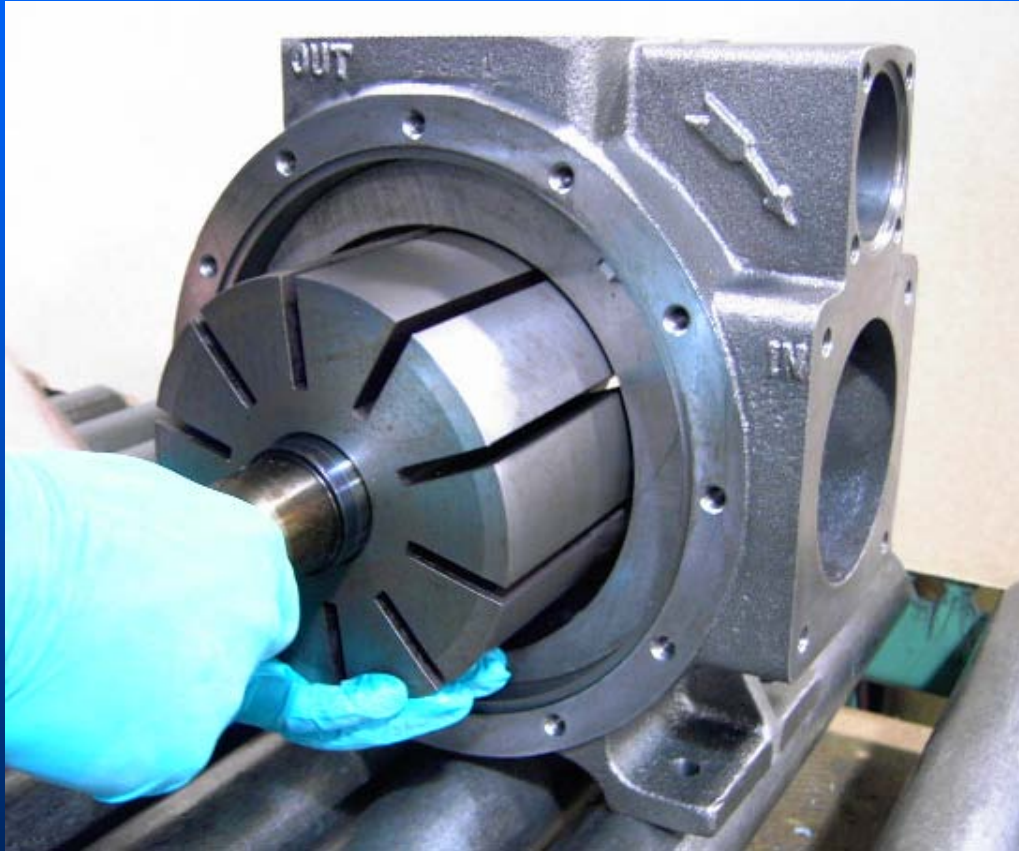
Rotor Installation

To install the rotor shaft assembly, install the cam, one head and sideplate. Then insert the rotor shaft assembly into the casing taking care not to hit the shaft on the sideplate.

After the shaft is inserted, install the blades and sideplate before installing the second head.

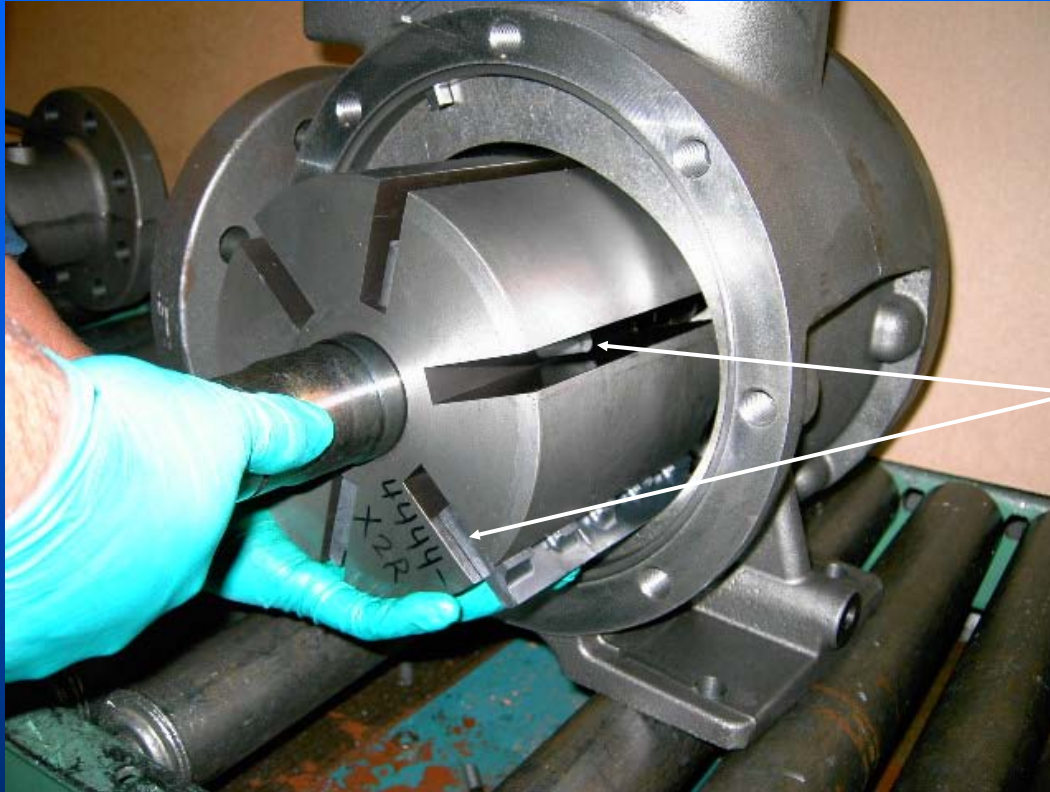
Installing Rotor on CD/CP Models

Insert the lower three blades and pins and support with lower hand during installation.

Install the opposite head with bearing and sideplate , but with out the seal. Support the rotor and shaft with one hand and guide with the other hand. Insert three blades and the pins, then with the supporting hand hold the blades and pins in position. Once shaft is installed insert the remaining blades.

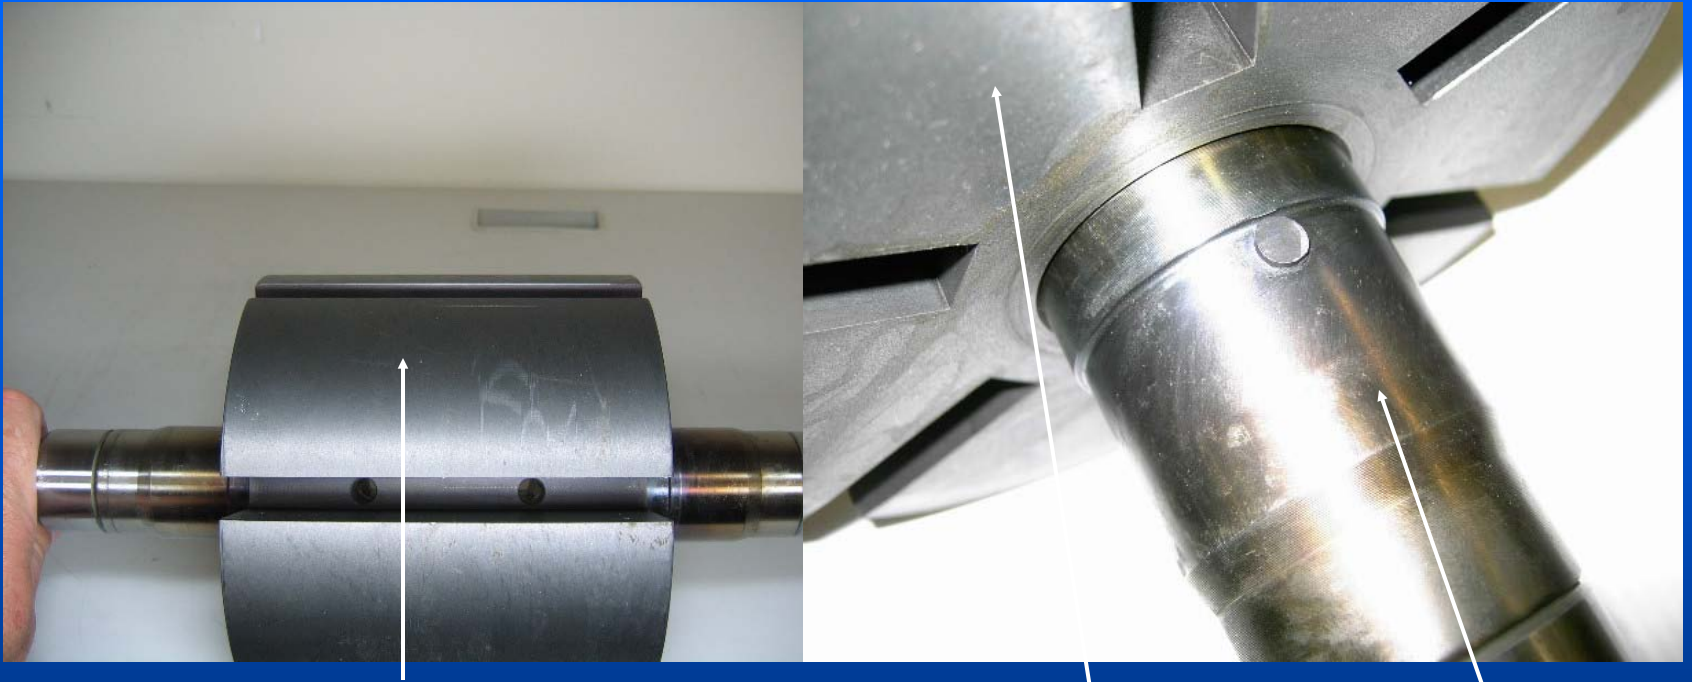
Inspect rotor outside diameter for scoring and wear. Wear in this area is typically caused by foreign material such as rust welding slag, etc.

Inspect the side of the rotor and the shaft OD where the seal O-ring rests for scoring and pitting. The shaft can be polished if needed. A file should be used to remove any burrs.

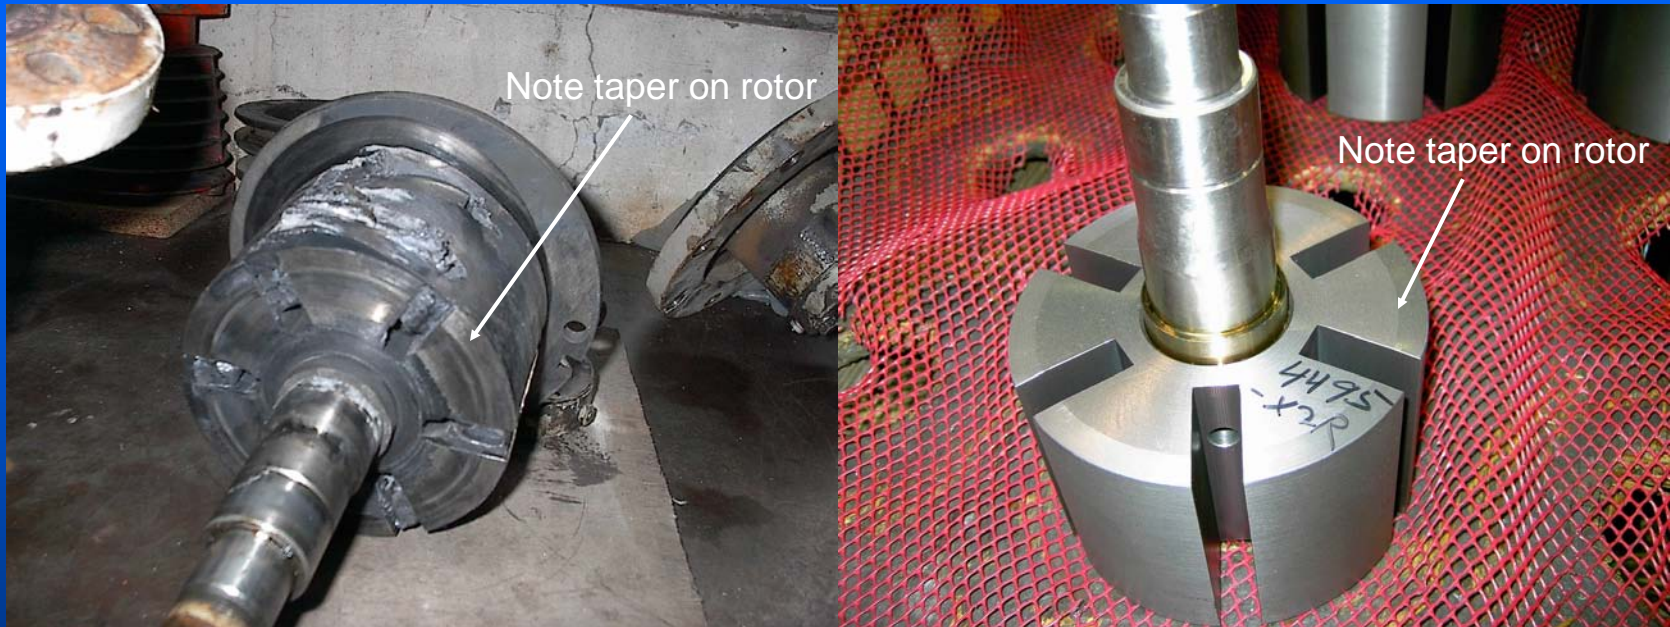
Rotor Shaft

The Rotor/Shaft assembly normally does not need to be changed. It usually is only damaged if foreign material is ran through the pump or if the bearings are not maintained. The rotor has a "taper" towards the outside diameter. If the taper can still be seen, the shaft is probably re-usable.

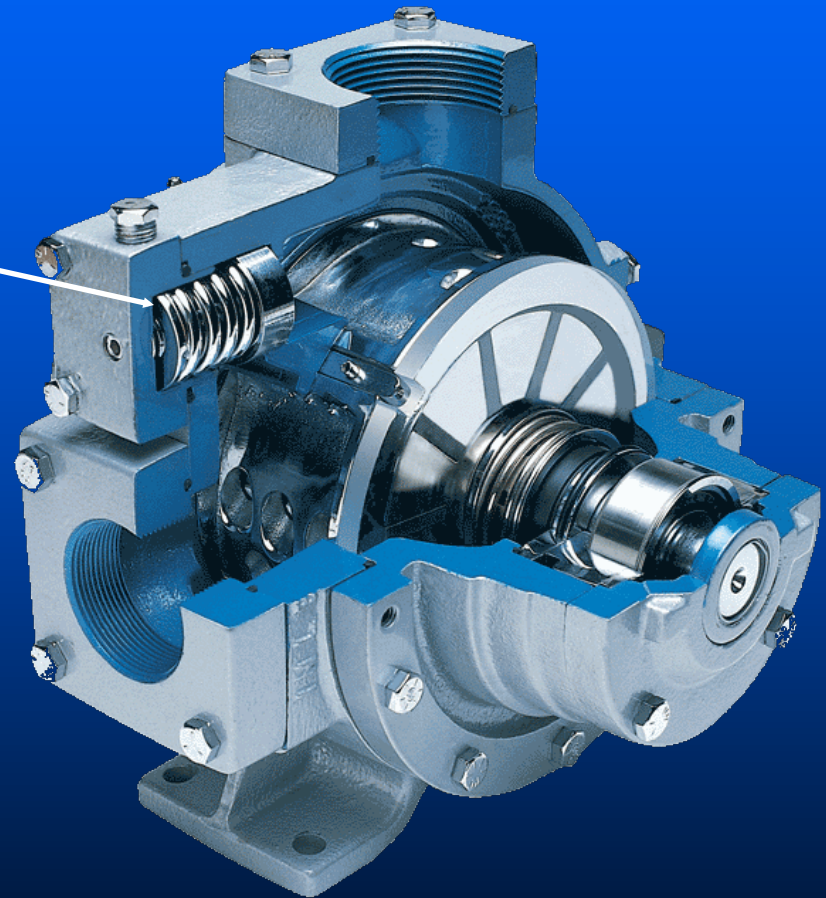
Relief valve – 521/1021

The internal relief is a safety device and should not operate under normal operating conditions. It is preset from the factory at about 150 PSI depending on the pump model number.

This areas should not be worn. If wear is noted, the pump has been operated at excessive pressures.

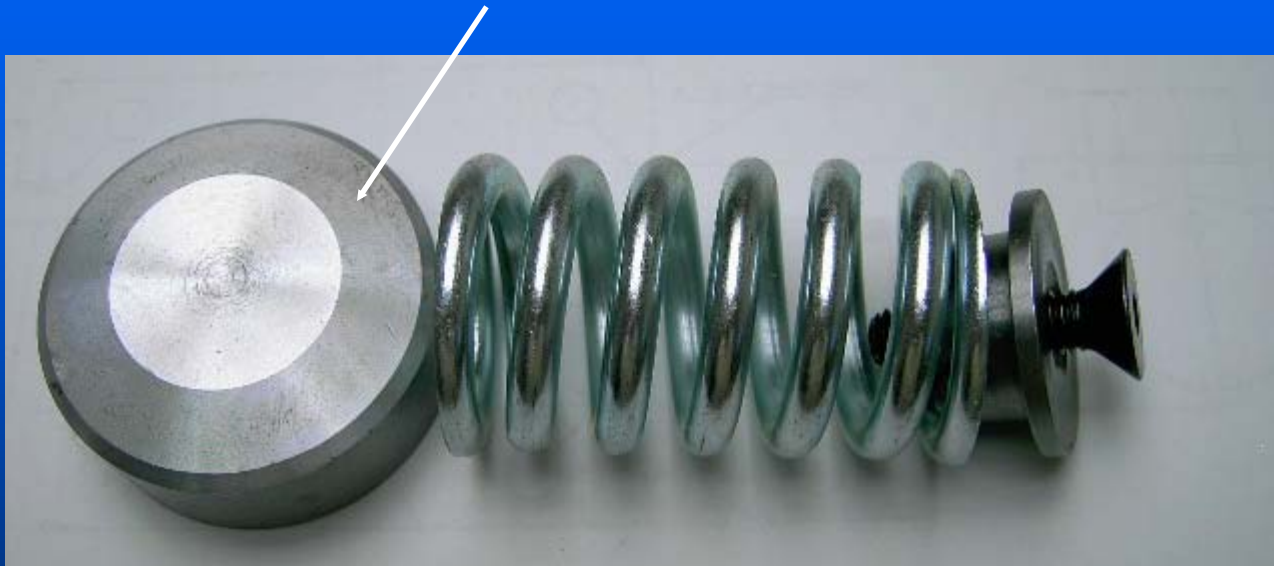
The internal relief valve is a “safety relief”. It is not a “bypass valve” and should only open if excess pressure is created. This valve is pre-set from the factory at around 150 PSI differential. The valve should be inspected for wear or rust if the pump is rebuilt. If wear is noted, the “external” bypass setting should be checked. This valve should not open during normal operation. To “field set” this valve turn counter clockwise until completely solid, and turn back clockwise approximately 1-1.5 turns.

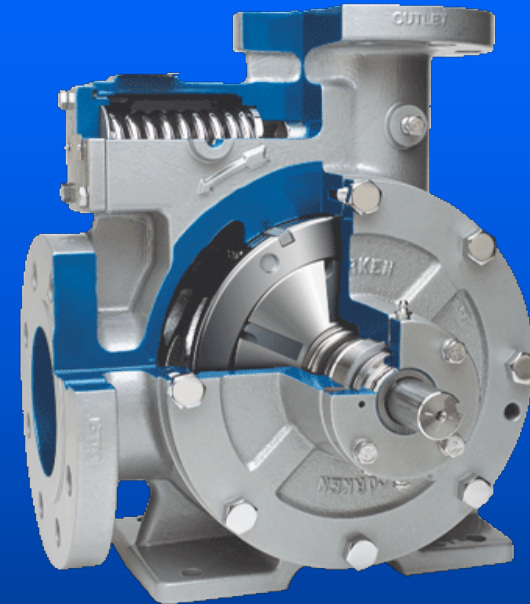
Z4500

Be sure to rotate the pump to assure it turns freely. Grease the pump before putting it into service. ALWAYS PRESSURIZE LIQUIFIED GAS PUMPS USING VAPOR!
