ME800 STEM ASSEMBLY REPLACEMENT KIT ME800-SARK

<READ AND UNDERSTAND ALL INSTRUCTIONS/NOTICES INCLUDED WITH THIS REPAIR KIT>
INSTRUCTIONS:

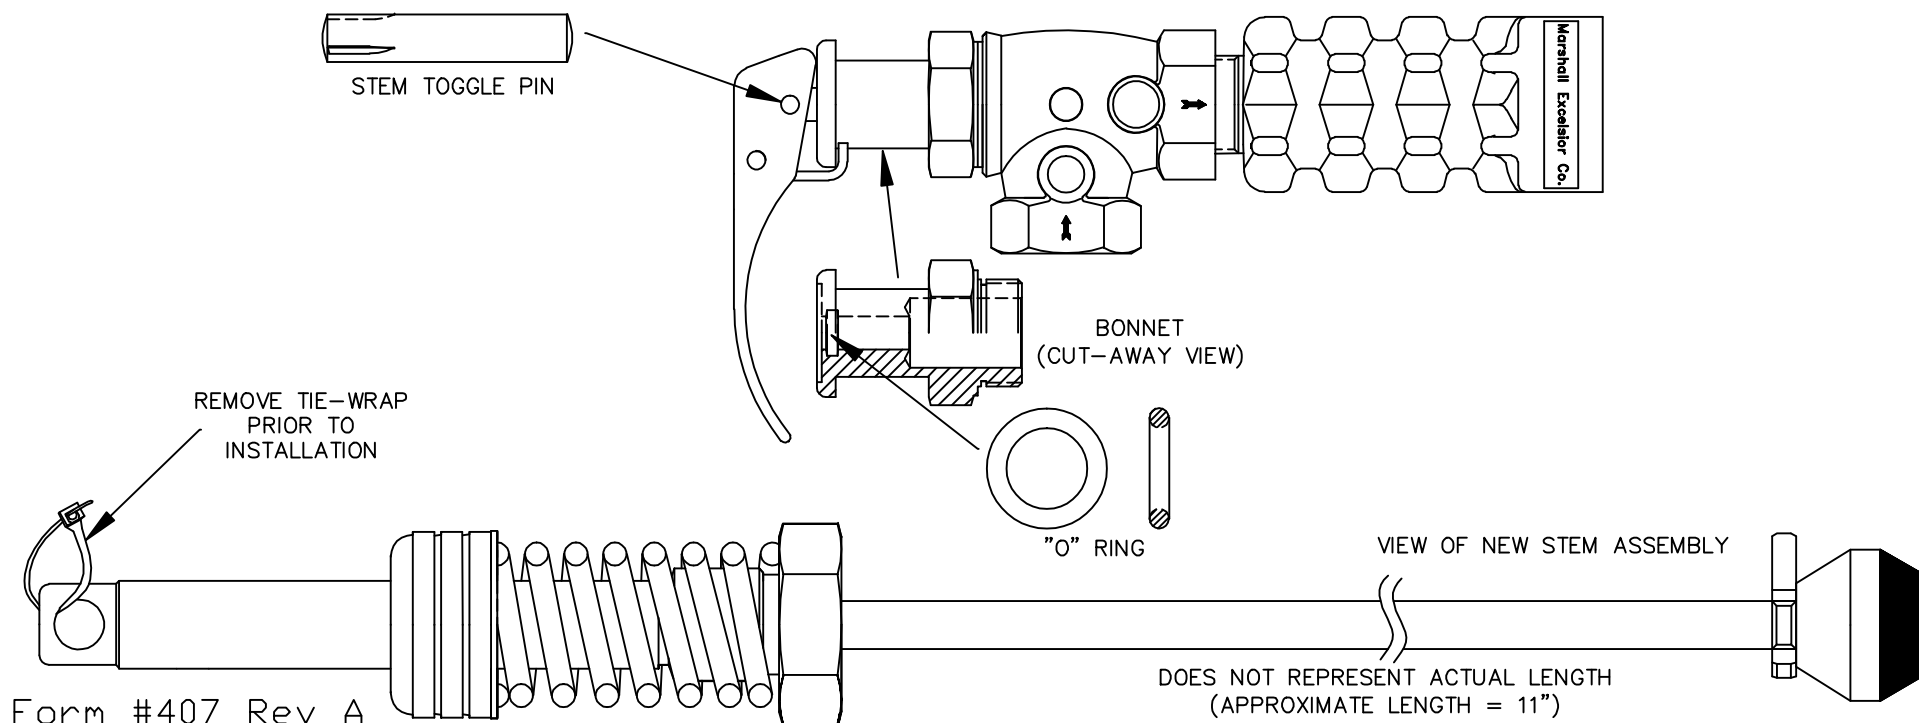
- 3) REMOVE THE STEM ASSEMBLY FROM THE BONNET. DISCARD THE OLD STEM ASSEMBLY AND REPLACE WITH THE NEW STEM ASSEMBLY AFTER REMOVING THE TIE WRAP SECURING THE UPPER STEM PACKING COMPONENTS. (REFER TO THE SCHEMATIC SHOWN ON PAGE 2).
