# ME800 UPPER SEAL REPLACEMENT KIT ME800-USRK

<READ AND UNDERSTAND ALL INSTRUCTIONS/NOTICES INCLUDED WITH THIS REPAIR KIT>  
INSTRUCTIONS:

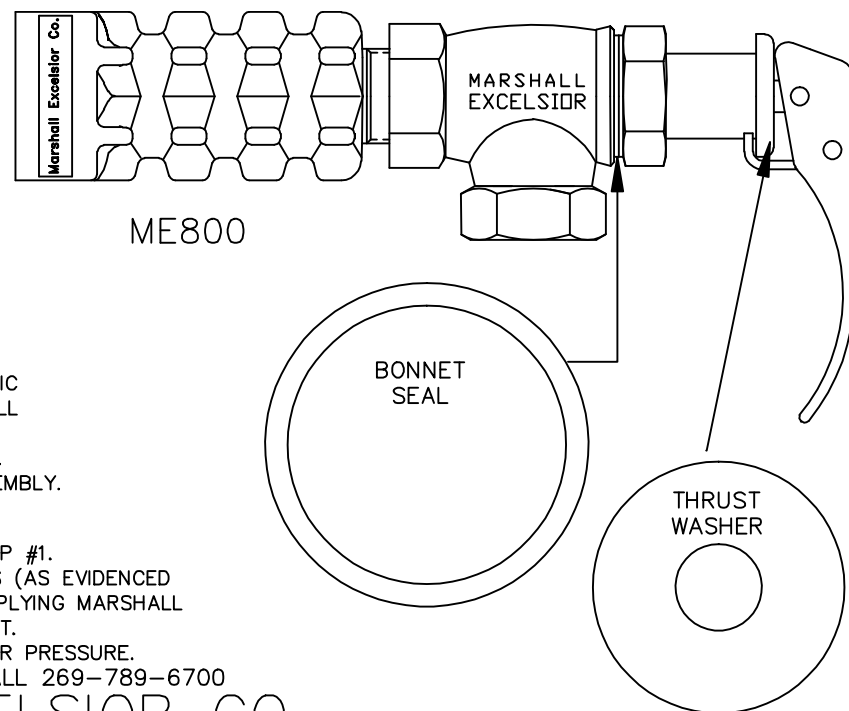
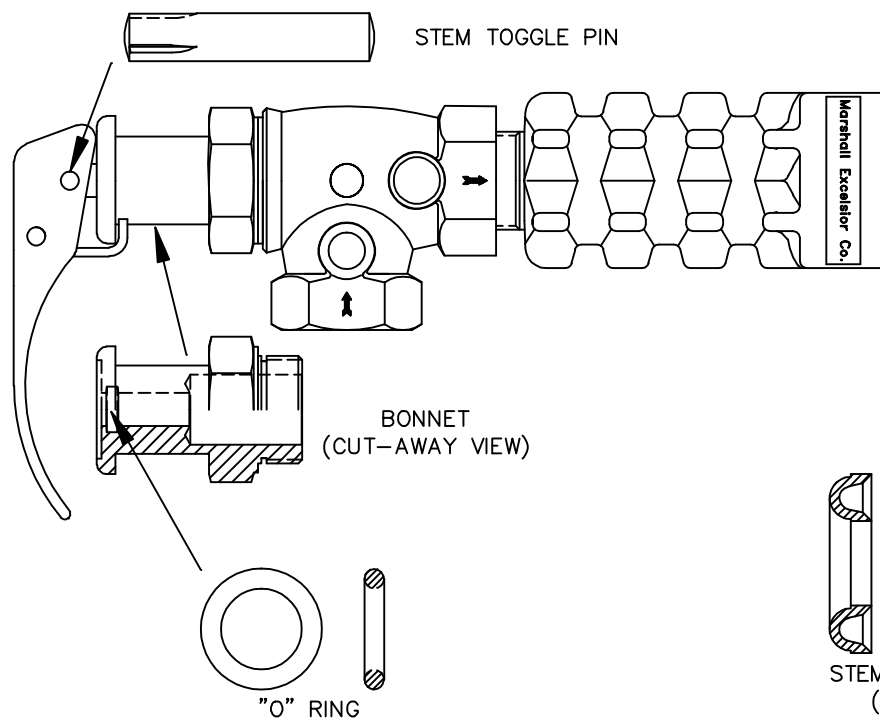
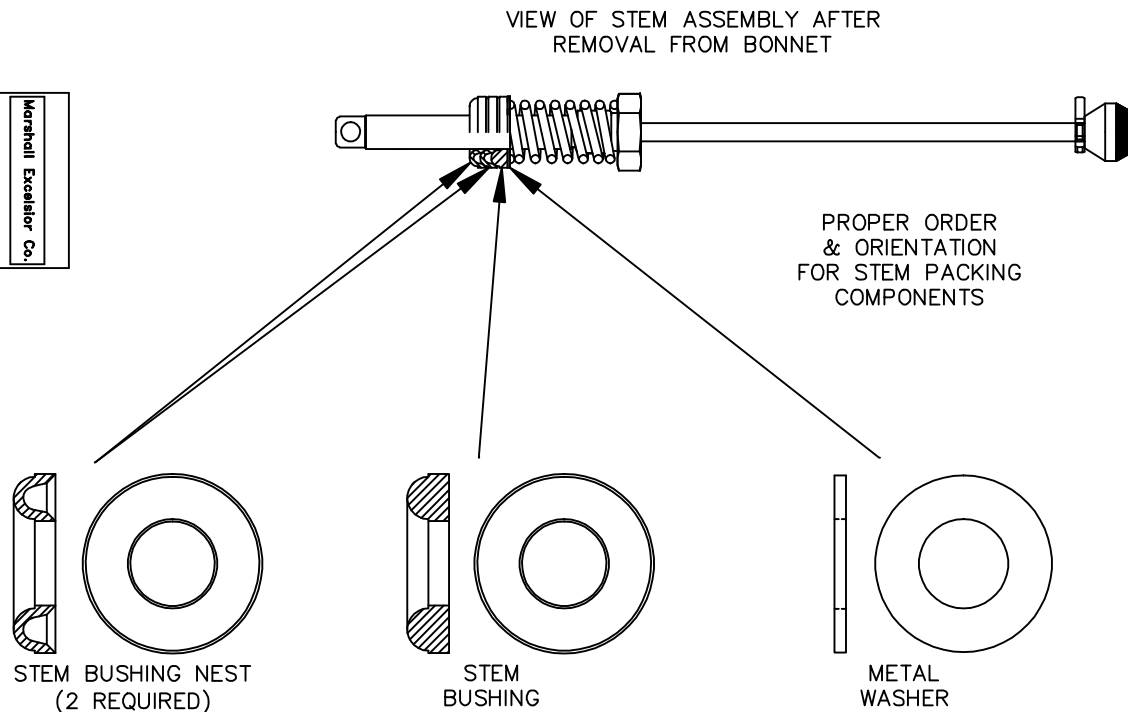
- 3) REMOVE THE UPPER STEM ASSEMBLY FROM THE BONNET. DISCARD THE METAL WASHER, STEM BUSHING AND STEM BUSHING NEST (2 PIECES) AND REPLACE WITH THE NEW UNITS IN THE SAME ORDER AS THE OLD ONES WERE REMOVED. (REFER TO THE SCHEMATIC SHOWN ON PAGE 2).

- 1) REMOVE THE STEM TOGGLE PIN TO REMOVE THE HANDLE. DISCARD THE OLD THRUST WASHER (LOCATED ON TOP OF THE BONNET) AND REPLACE WITH THE NEW THRUST WASHER.

- 2) REMOVE THE BONNET BY TURNING IT COUNTER-CLOCKWISE USING A CRESCENT WRENCH WITH THE BODY SECURED IN A VISE. DISCARD THE OLD BONNET SEAL (LOCATED BETWEEN THE BONNET AND BODY) AND REPLACE WITH THE NEW BONNET SEAL.

- 4) REMOVE AND DISCARD THE O-RING LOCATED INSIDE THE TOP OF THE BONNET (USE A NON-METALLIC DEVICE SUCH AS A TOOTHPICK TO AVOID SCRATCHING THE SEALING SURFACE). LUBRICATE AND INSTALL THE NEW O-RING (USE LUBRIPLATE #107, OR EQUIVALENT - NOT INCLUDED).
